# **AIR ACCIDENT INVESTIGATION SECTOR**

# **AIR ACCIDENT INVESTIGATION REPORT**

Uncontained Cargo Fire Leading to Loss of Control  
Inflight and Uncontrolled Descent Into Terrain

Boeing 747-44AF  
N571UP  
Dubai  
United Arab Emirates  
03 September 2010

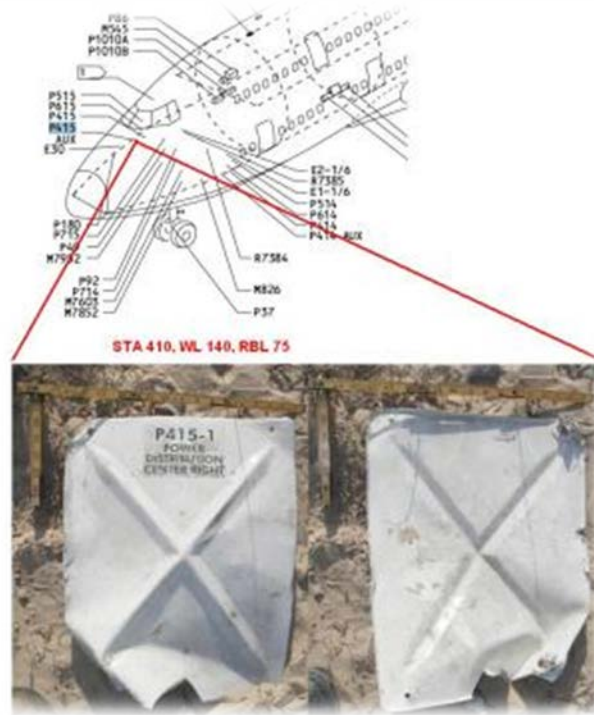
Photo 6 Cover from power distribution center

The cover from the power distribution center right was found to have a light sooting on the exterior and interior surfaces. There was no thermal degradation associated with this component which would have been located at approximately body station 420 on the lower lobe.

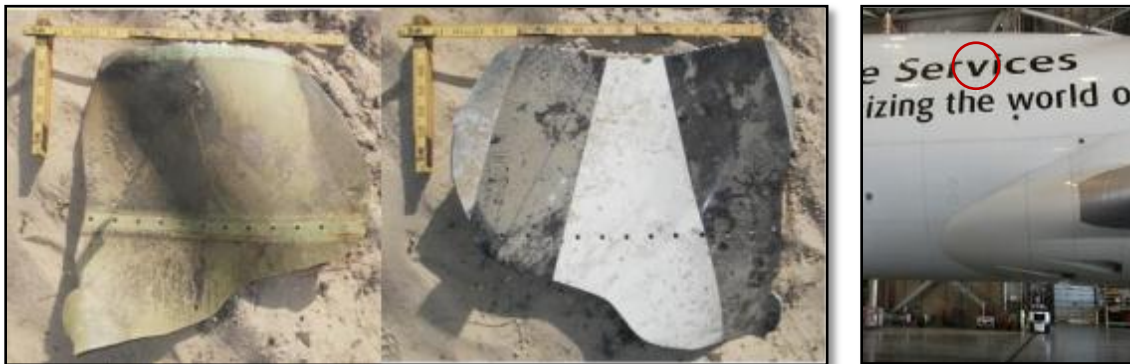
Photo 7 Recovered Fuselage skin section [LH]. Exemplar aircraft exterior [RH]

The fuselage skin piece was a heavy gauge (~.125") skin piece from fuselage. On the interior surface there is sooted corrosion inhibiting compound (CIC) around a protected surface which became exposed after the aircraft breakup. On the exterior surface of this part is a portion of lettering identified as belonging to the letter "V" from the text "Worldwide Services" displayed along the upper lobe on the left side of the aircraft.

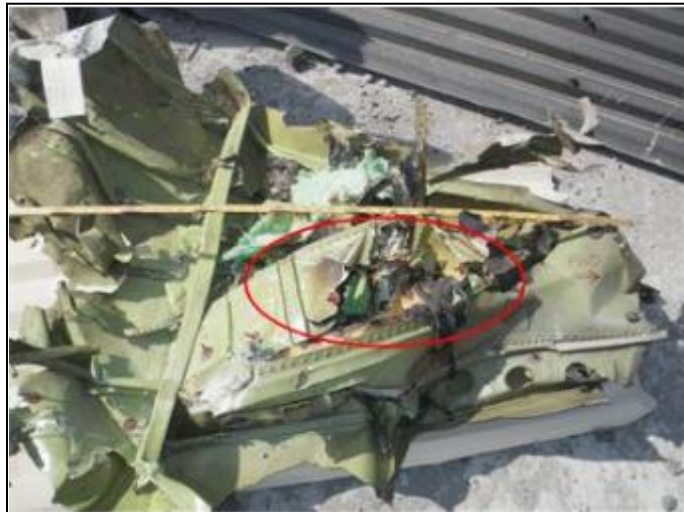
Photo 13 Portion of nose door (lower right hand side)

This portion of the nose door was from the lower part of nose door on the right hand side near station 180. This item exhibited localized charring of the primer and some burnt insulation in the area shown circled in

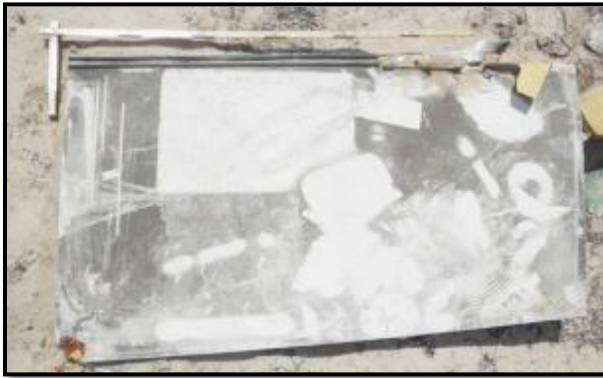
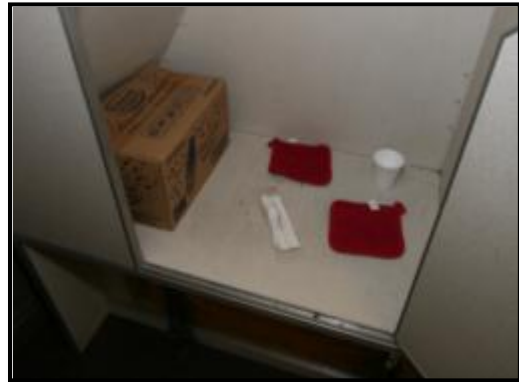
Photo 18 Shelf from galley cabinet [LH]/ Galley shelf behind flight deck bulkhead in exemplar aircraft [RH]

The shelf originated from the cabinet behind flight deck bulkhead. The shelf has heavy soot stains around outlines of items that had been sitting on the shelf during flight.

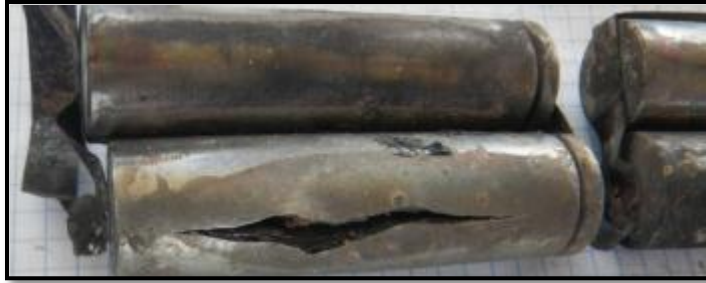
Fire damaged remains of battery pack with a fractured cell

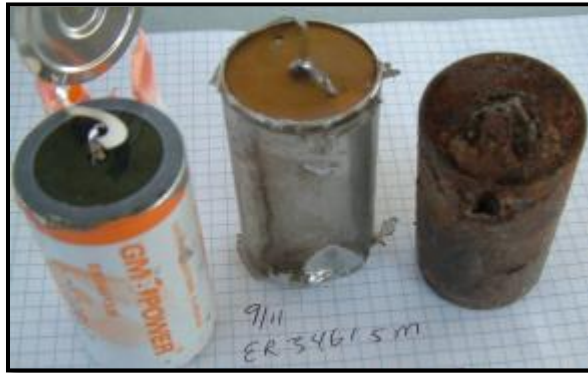
Additional battery pack remains [LH]/D-Cell size lithium primary batteries. Photo shows fire damaged and undamaged batteries [RH]

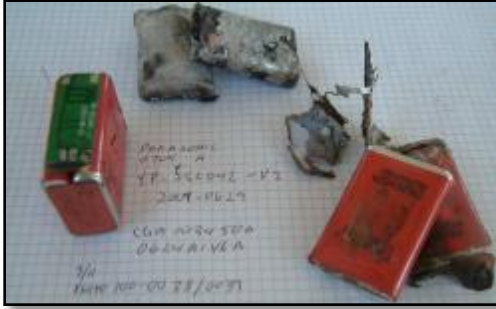
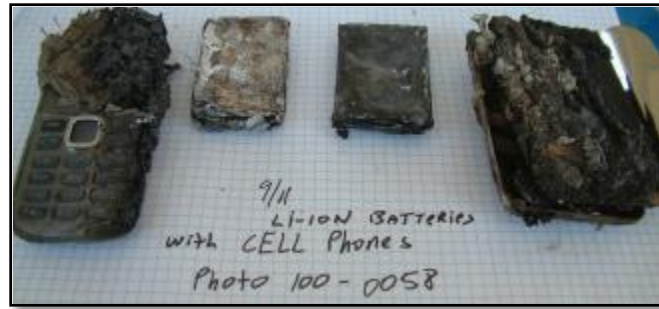
Intact and fire damaged Panasonic batteries (2-pack Li-ION set)[LH]/Mobile phones and batteries [RH]

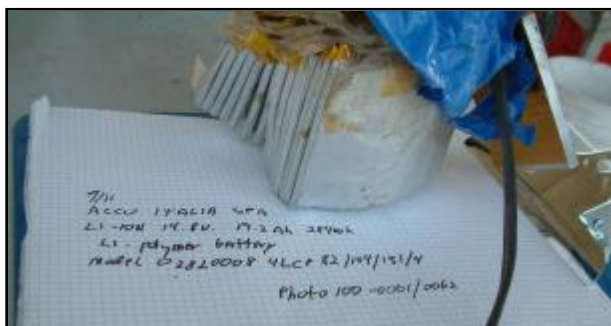
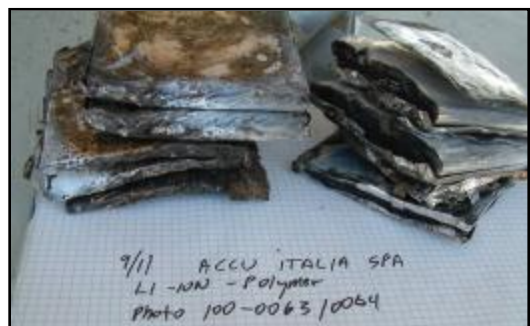
Lithium-ion polymer type battery pack [LH]/ Lithium-ion polymer type battery pack with thermal damage [RH]

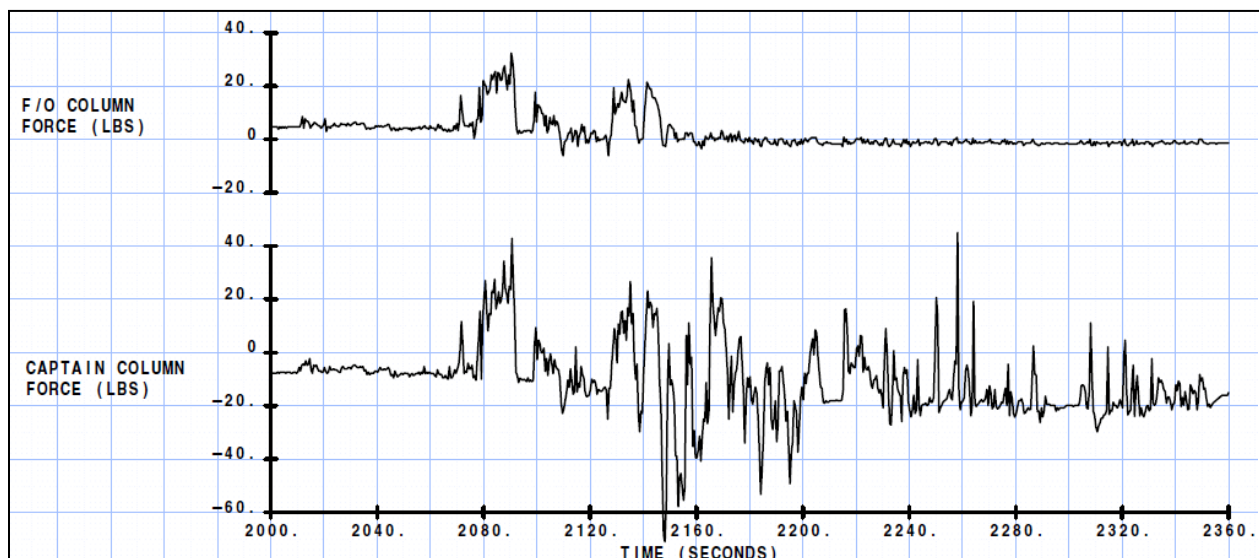
Figure 51 Captain and First Officer column forces following the fire warnings

The captain's column force parameter does not go to zero but it does require less force for the same change in column deflection. This is likely due to the fact that the captain's forward quadrant contains a tension regulator that was designed to remove slack from the elevator control cable. In effect the tension for the captain was less than normal but greater than zero while the tension for the F.O was effectively zero.

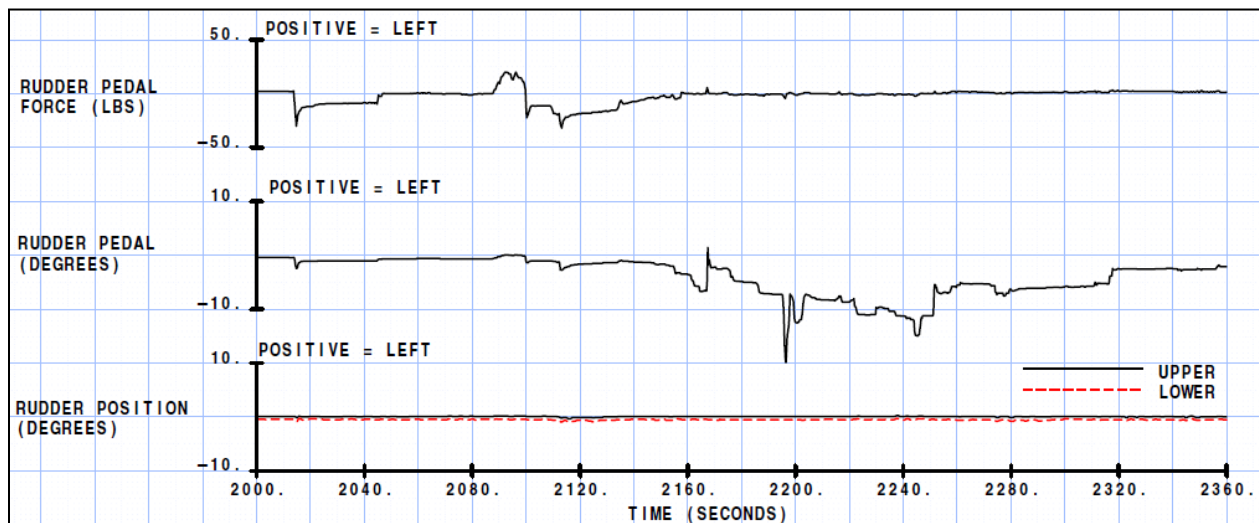
Figure 52 Rudder and rudder pedal data

During the first segment the pedal force moves the pedal. For the rest of the time segment much larger changes in pedal are seen with no pedal force. In addition the 10 degree rudder pedal inputs are not deflecting the rudder. Both of these effects can be caused by a loss in tension of the rudder control cable.

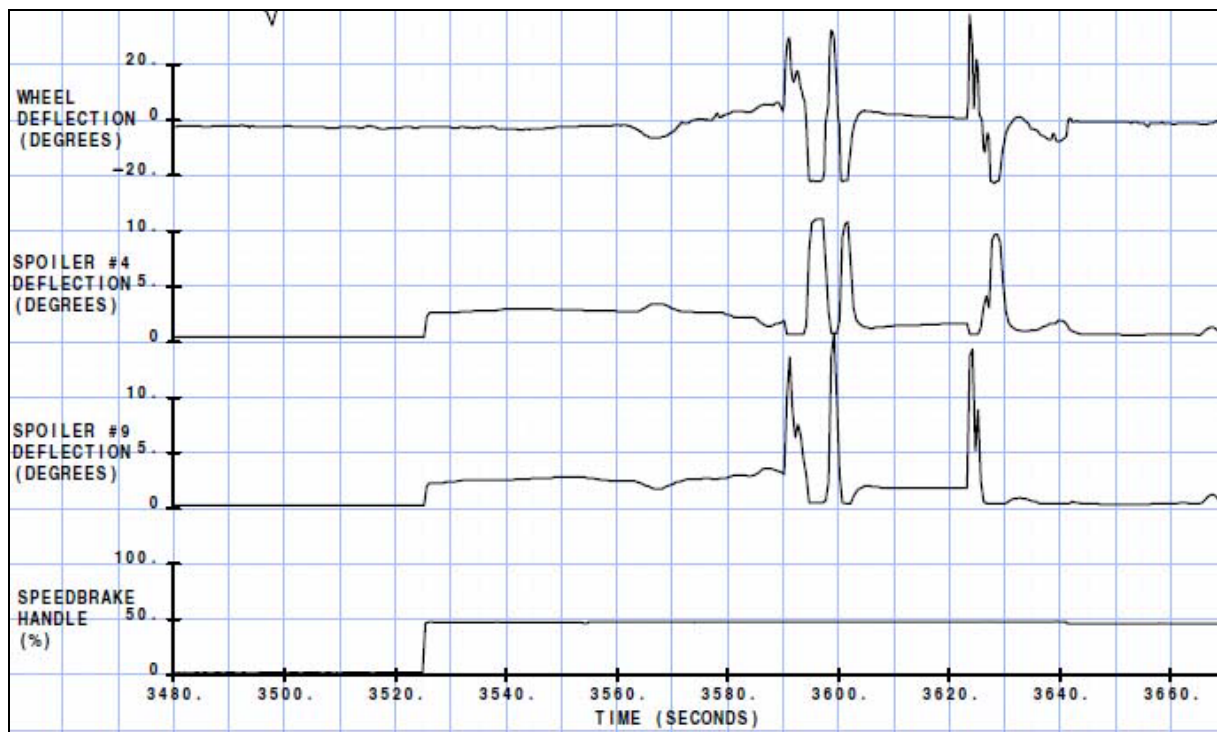
Figure 53 - Spoiler deflection from speed brake handle and wheel deflection

The Figure below demonstrates the inconsistency between speed brake handle and spoiler deflection – At 15:38:09 to end of flight the spoiler response to speed brake handle when moved to flight detent position was only 3 to 4 surface degrees for flight spoilers #4 and #9 Normal response to speed brake flight detent for these spoiler surfaces would be greater than 25 degrees at the flight conditions. The spoiler panels responded normally to wheel inputs during this time period which demonstrates that these spoiler surfaces had capability to move further. Spoiler deflections are consistent with the flight path of the aircraft.

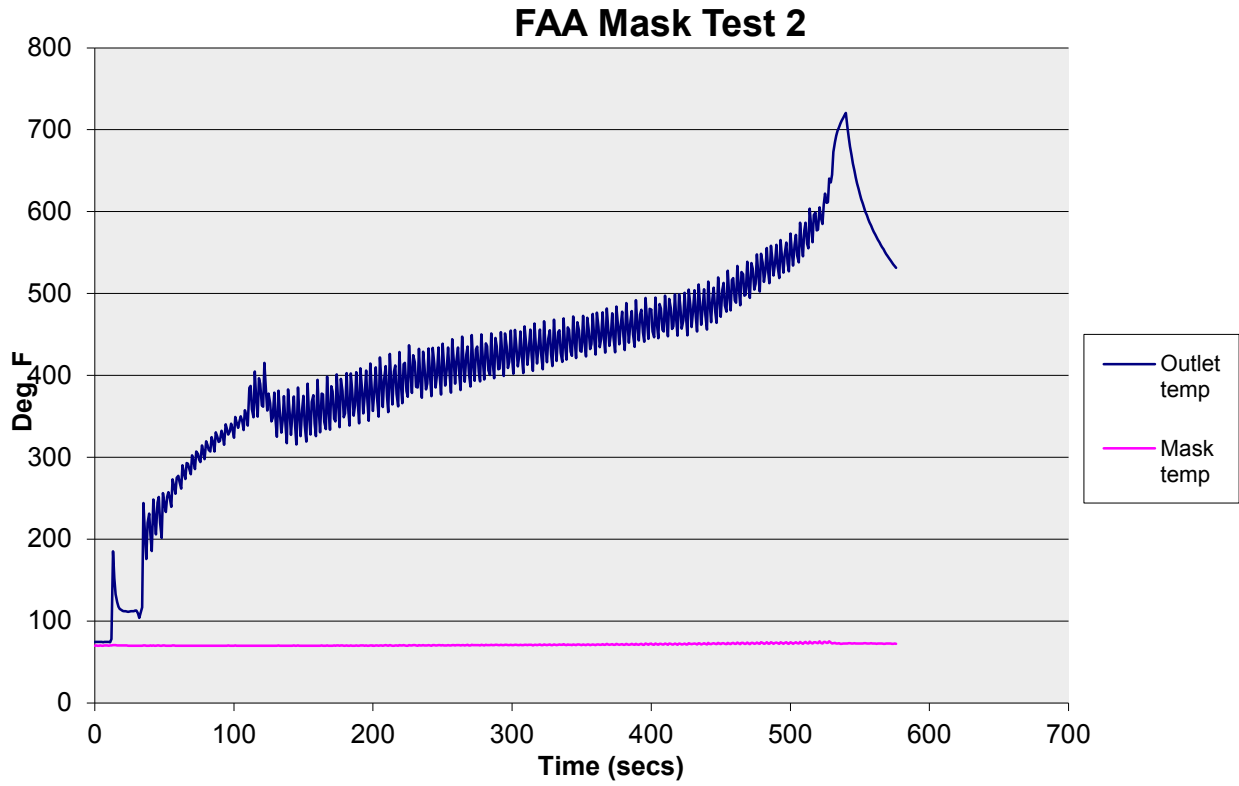
**Mask Test #2 Flex Hose 60B50059 hose failure**

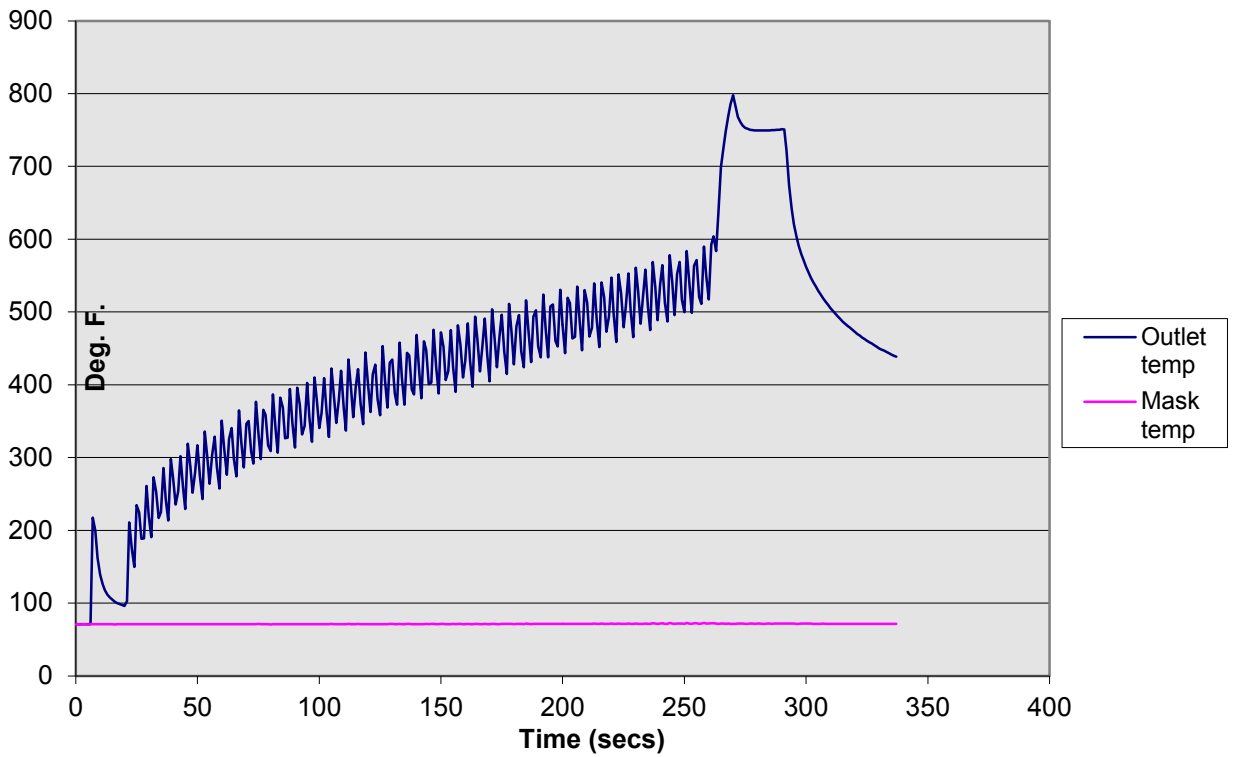
Mask Test #3 Flex Hose 60B50059 hose failure
