# **AIR ACCIDENT INVESTIGATION SECTOR**

# **AIR ACCIDENT INVESTIGATION REPORT**

Uncontained Cargo Fire Leading to Loss of Control  
Inflight and Uncontrolled Descent Into Terrain

Boeing 747-44AF  
N571UP  
Dubai  
United Arab Emirates  
03 September 2010

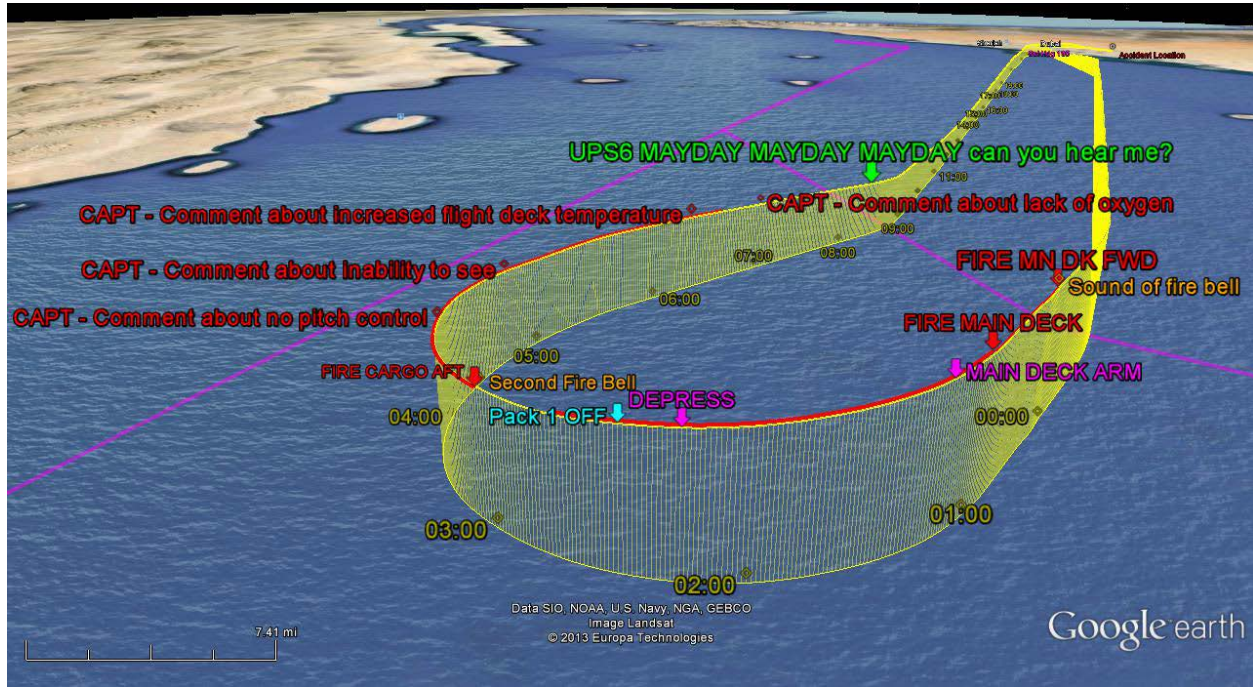
Figure 2 Inflight Turnback Fire Suppression Activation

- 15:14:57|CVR|F.O: Can you hear me?
- 15:14:58|CVR|CAPT: No, I can't hear you.
- 12:15:17|CVR|F.O: Why can't I hear you?

This communication problem appeared to be resolved as the flight progressed.

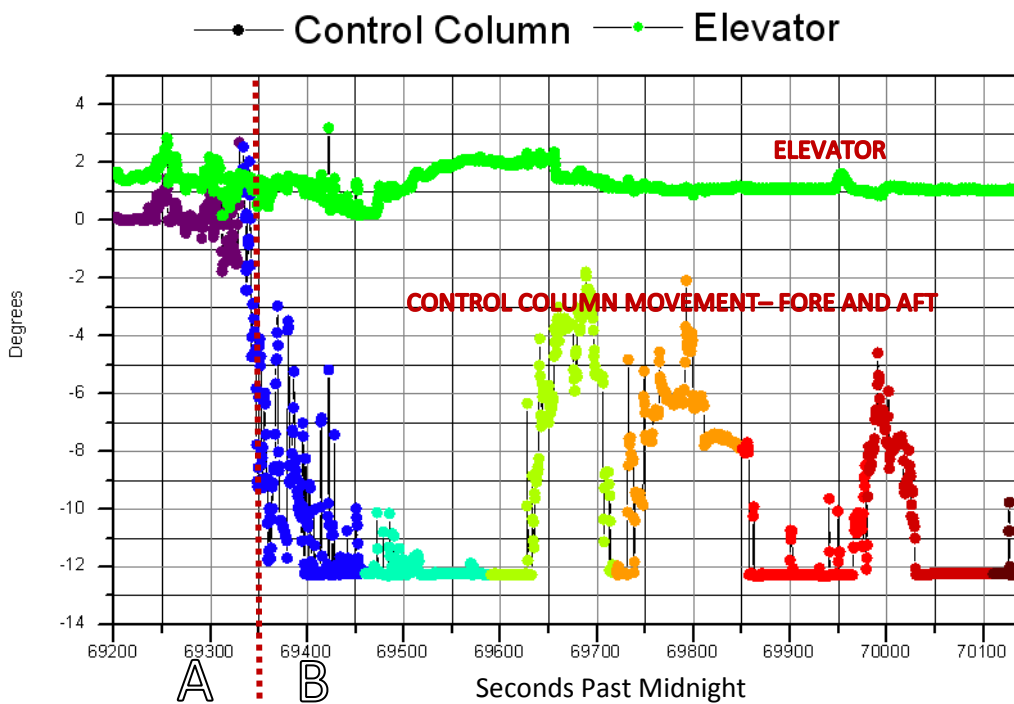
Figure 18 control synchronization/desynchronisation

The PF made a series of pitch inputs which had a limited effect on the descent profile; the descent is arrested temporarily. There then followed a series of rapid pitch oscillations. These were not phugoid oscillations, these were commanded responses where the elevator effectiveness decreased rapidly as the airspeed decayed and the elevators could not compensate for the reduced thrust moment from the engines to maintain level flight in a steady state. This was due to the desynchronisation of the control column inputs and the elevators.

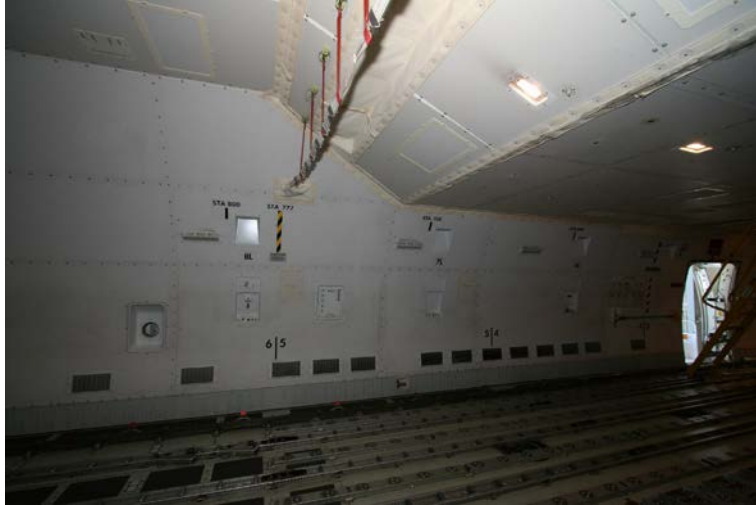
The linings in the proximity to the location of the fire in zone3 are shown below in green.

Picture 1 Cargo Compartment Liner Transition Panels At The Fire Location

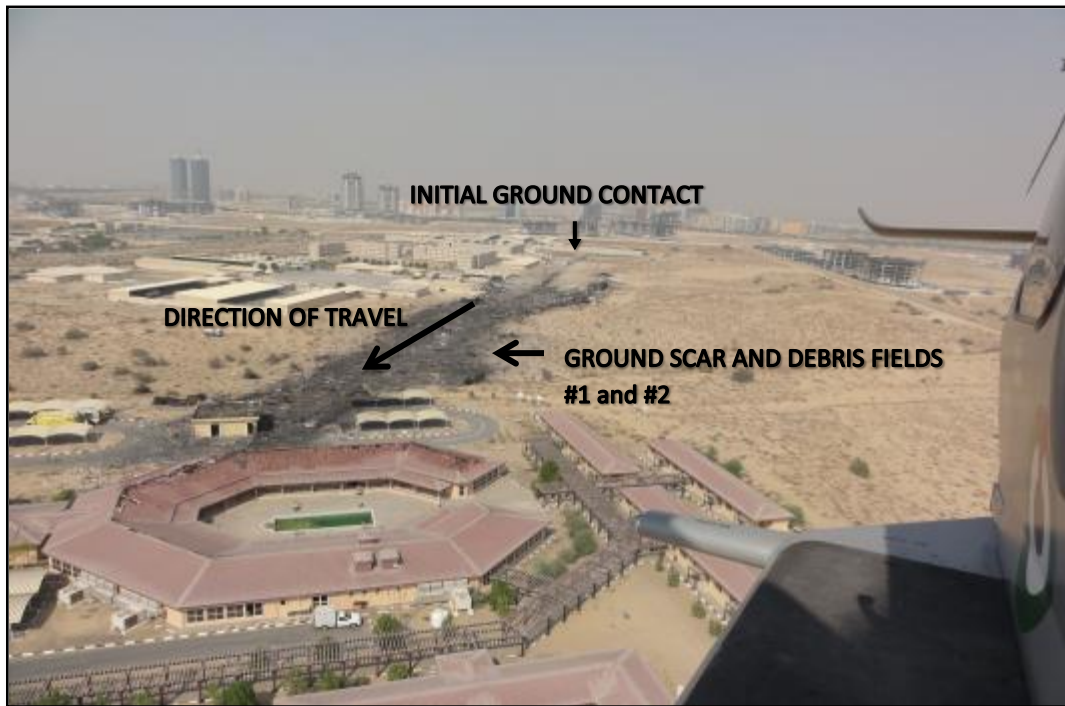
The wings, center and forward fuselage were spread over a 300 meter area, with the cargo, some of the aircraft systems and associated on board equipment distributed around the debris field.

The majority of the wreckage was damaged in the post-accident fire.

Photo 1 View looking over Nad Al Sheba military base towards the residential area of Silicon Oasis, Dubai

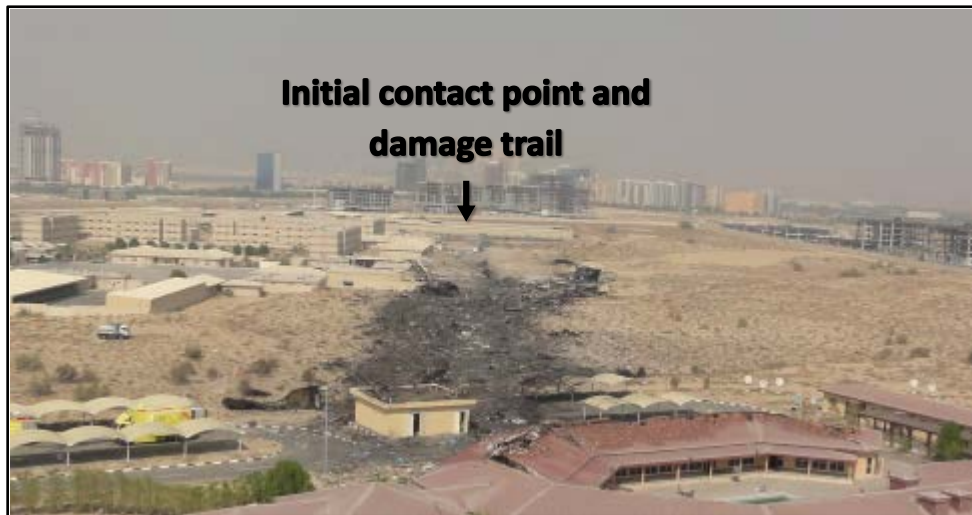
The accident aircraft impacted the ground inside the confines of Nad Al Sheba military base nine nautical miles south of Dubai, United Arab Emirates. During the impact, the aircraft destroyed an unknown number of buildings and trucks. There was an extensive post-crash fire which consumed the bulk of the aircraft and remaining cargo.

Photo 2 Overall view of the debris field, looking back towards the initial impact location

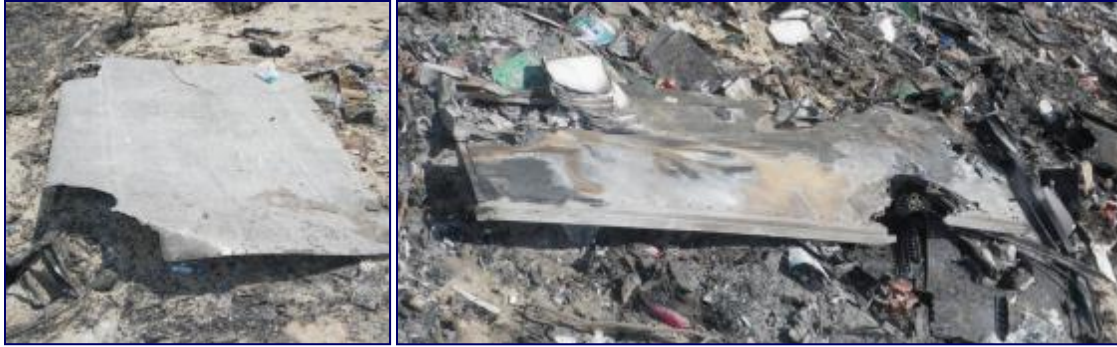
The cargo containers and pallets were all destroyed by the impact forces and post-crash fire. The few recognizable parts of the containers and pallets were base plates and a few doors. All of the pieces identified as being parts of containers and pallets were examined for recognizable in-flight fire damage. Due to the severe post-crash fire damage to these components, no particular in-flight fire characteristics were observed. The contents of the cargo containers were spread throughout the debris field, both inside and outside the post-crash fire zone. Details about the cargo contents, as declared by the shippers and contained within the cargo manifest, can be found in the cargo group's factual report.

Photo 3 Cargo container base plate [LH] and cargo door [RH]

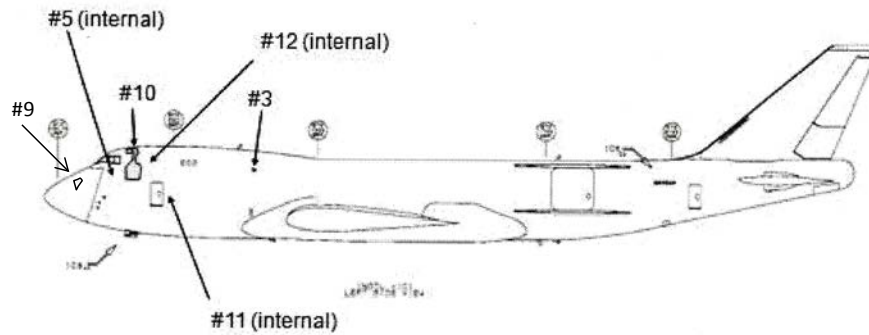
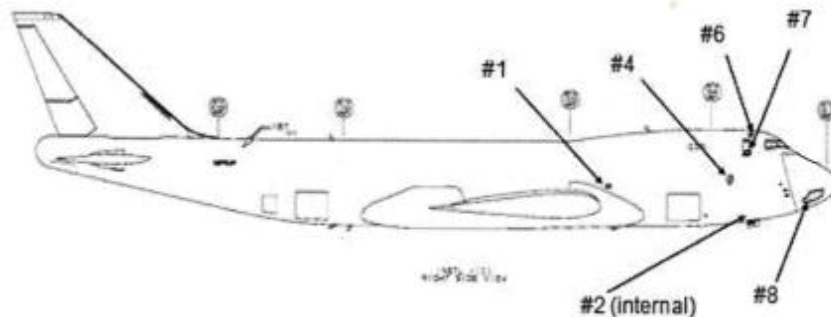
Left hand side outline of accident aircraft depicting locations of identified items

Right hand side of accident aircraft depicting locations of identified items

#1: Fuselage observation window	#7: Hinge casting
#2: Cover from power distribution center	#8: Part of nose door (lower)
#3: Fuselage skin	#9: Part of nose door (upper)
#4: Fuselage skin & structure	#10: Portion of structure and fuselage skin
#5: Structure with pulley attached	#11: Stair to flight deck

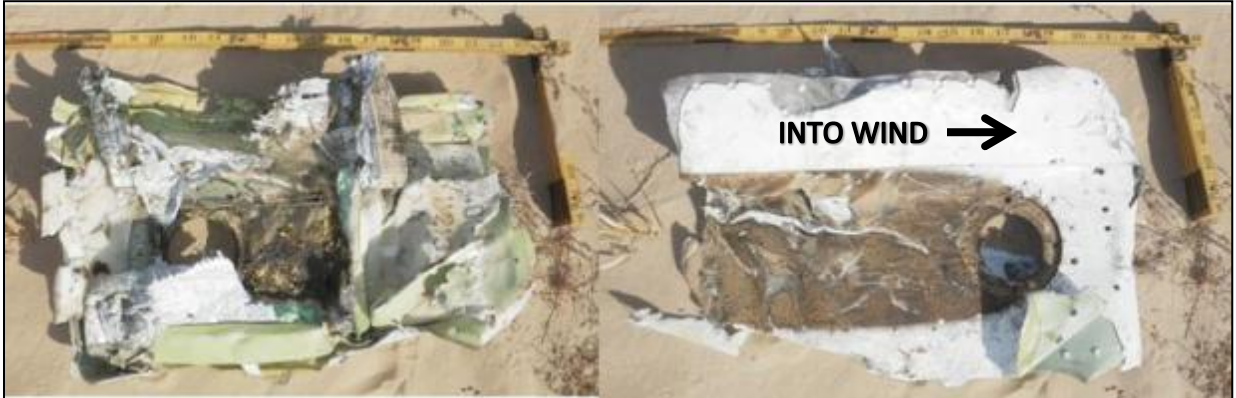
#6: Fuselage skin with smoke shutter cut-out

The portion of fuselage skin contained the cut-out for the flight deck's smoke evacuation shutter. The actual smoke shutter had separated from this portion of the fuselage. A very thick soot trail almost resembling tar extended from the cut-out location aft to the end of the recovered portion of fuselage.

Photo 10 Fuselage skin piece with smoke shutter cut-out (interior on the left, exterior on the right)

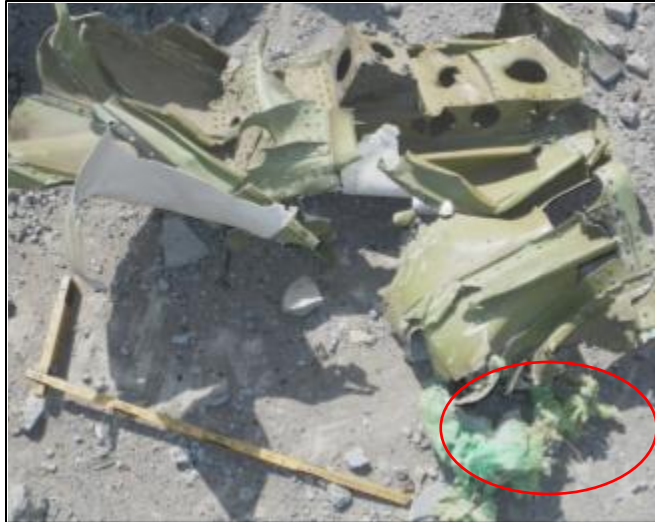
#9 Portion of nose door (upper)

This portion of nose door was from the upper portion of the door on the left hand side approximately between stations 160 to 200. This piece exhibited some localized discoloration of primer shown circled above.

Photo 14 Portion of nose door (upper)

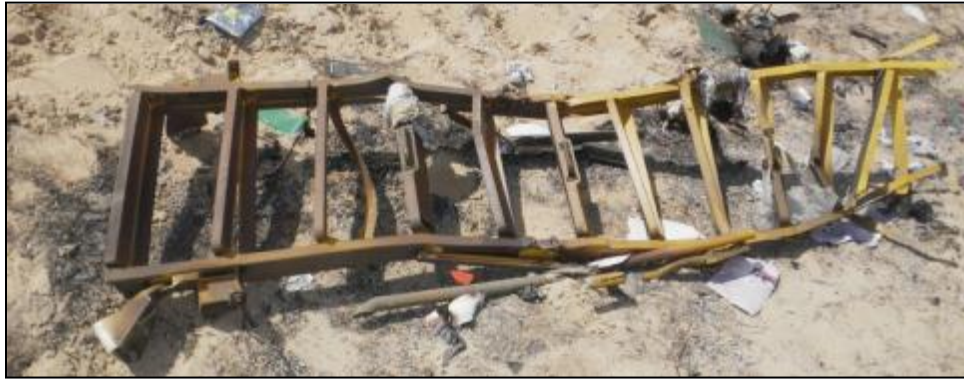
The stairs to the flight deck extend from the floor of the main cargo deck up to the upper deck. The stairs have sooting at the top portion of the stairs which then tapers off towards the bottom. This soot graduation is consistent with a stratified smoke layer existing within the main cargo deck.

Photo 16 Stairs to the flight deck

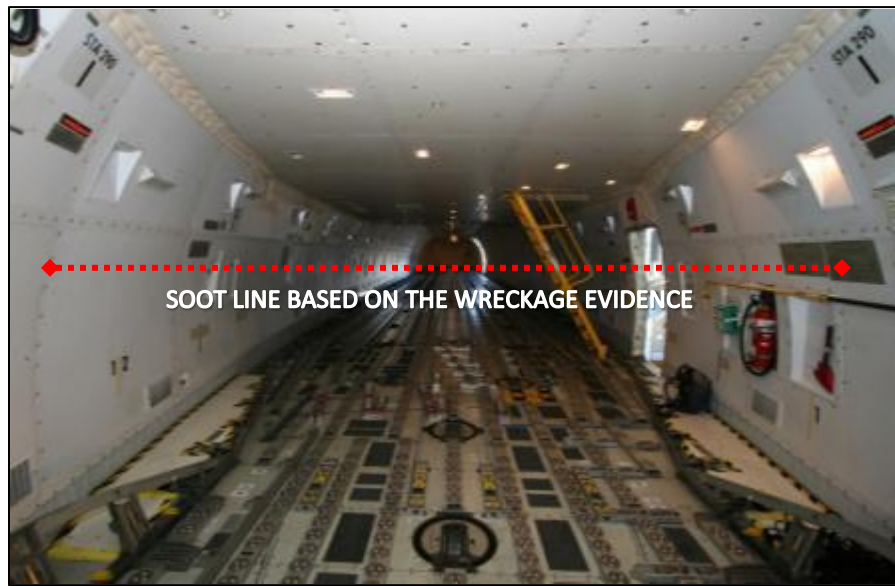
The demarcation of sooting on the stairs suggests a smoke layer extending to the height shown by the dotted line in photo 17 below.

Photo 17 Exemplar interior showing stairs to the flight deck and a dotted line showing the level of the smoke layer

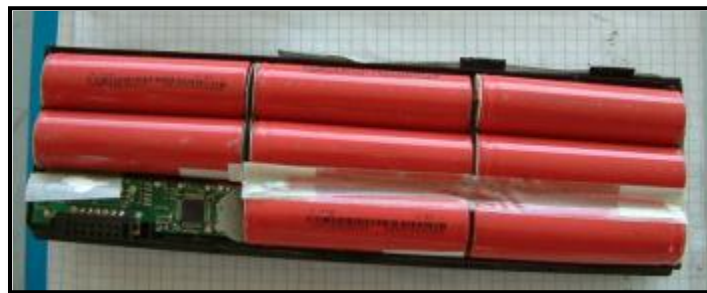
Lithium-ion battery pack.

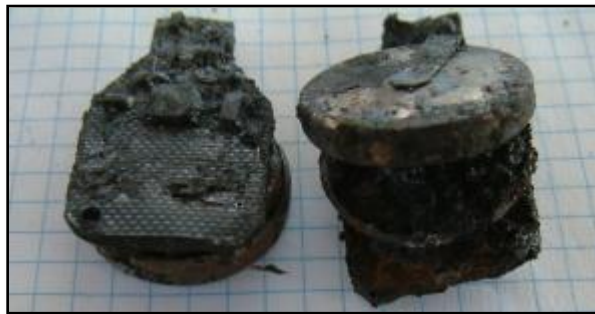
Lithium primary button sized flat cell batteries (watch style) with small circuit board

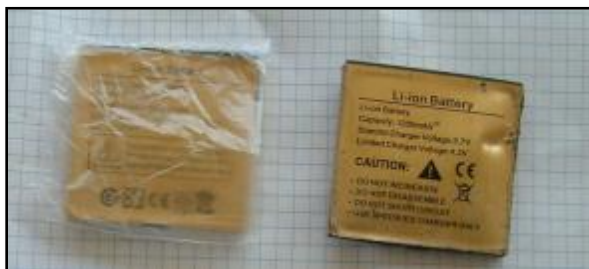
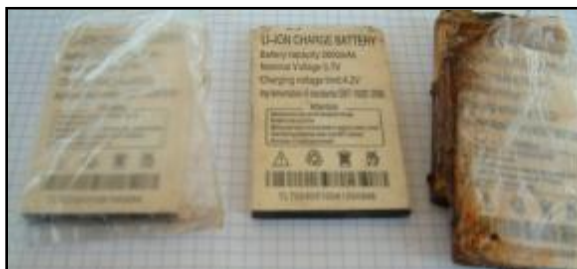
Lithium-ion, mobile phone type battery

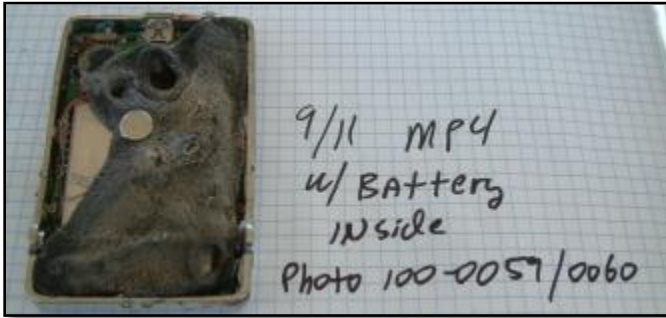
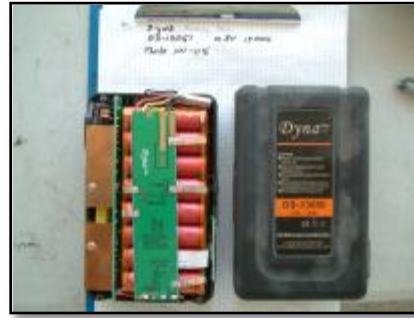
Personal electronic device with battery inside [LH]/Lithium-ion battery pack [RH]

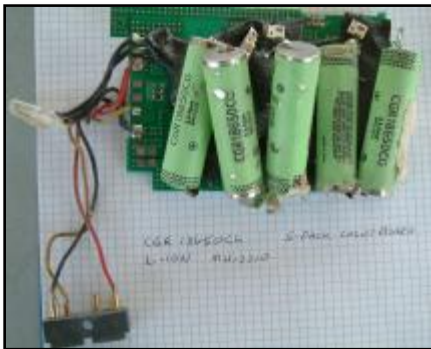
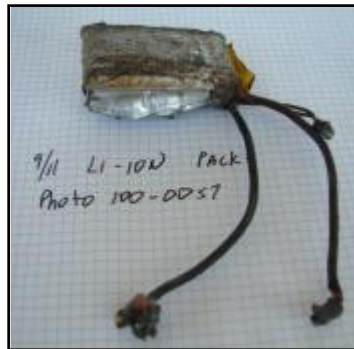
Lithium-ion battery packs - LH and RH

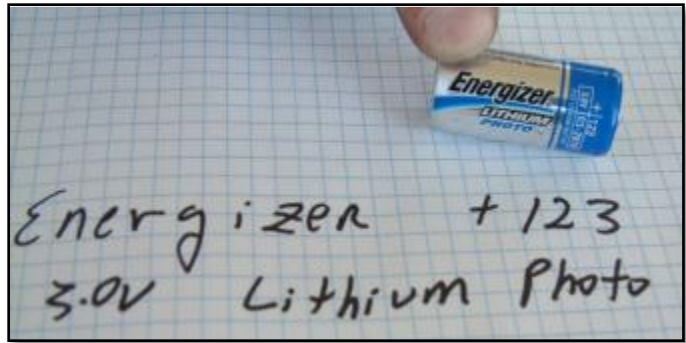
Lithium primary (CR123 type) battery

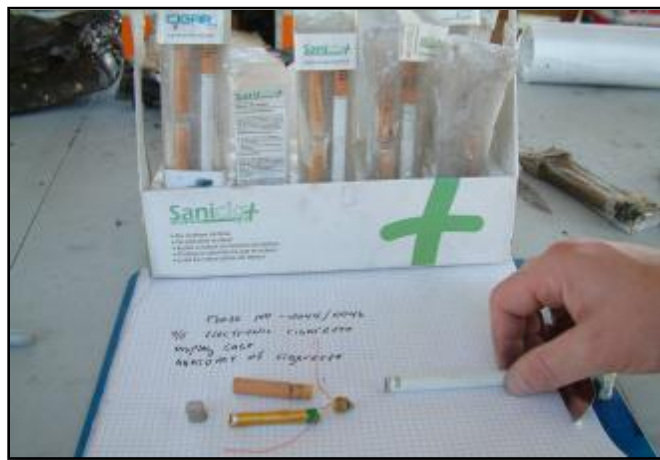
Electronic cigarettes containing lithium primary batteries<sup>55</sup>

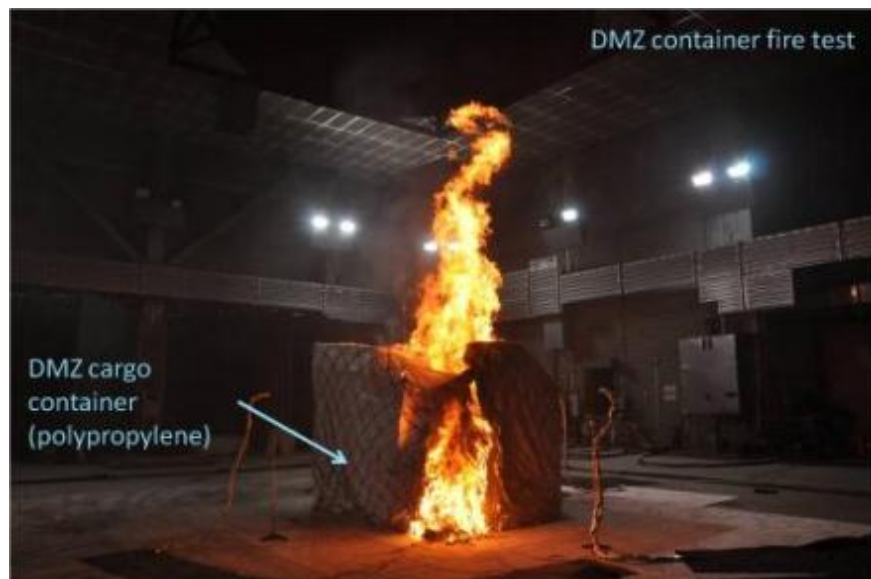
Photo 2 - NTSB DMZ Cargo Container fire depicting a polypropylene cargo container burning at a rate of 8.45MW, 132 seconds after becoming detectable to an aircraft-based smoke detection system.

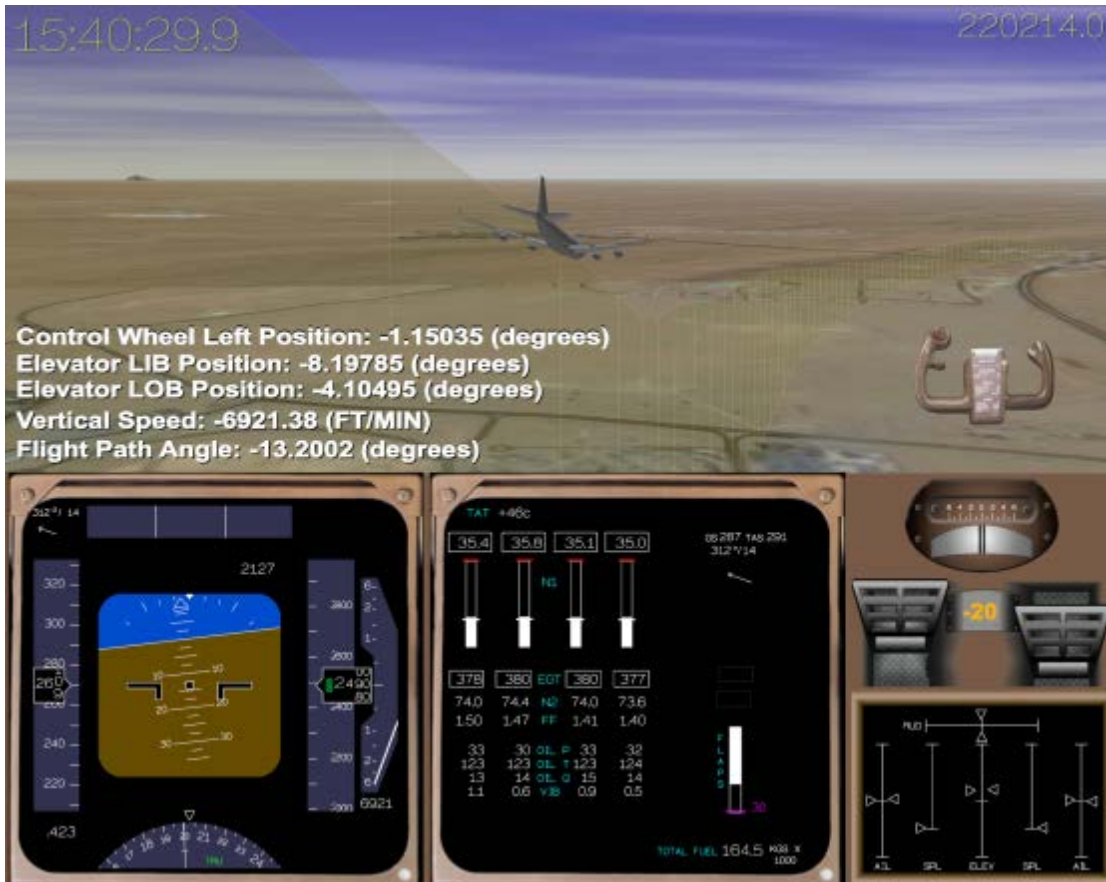
Figure 44 - 15:40:30 UTC Descent Towards Nad Al Sheba

began to descend. The transducer measuring the Captains column force and column deflection display rapid nose-up pitch commands during the final 40 seconds. Elevators moved with the nose-up column inputs but the deflection was inconsistent with the relationship seen at the beginning of the flight.

Aircraft heading crossed through the target (195 deg.) and continues as there was no wheel input to return to wings level.

The aircraft responds to the control inputs from the PF and the rate of descent is reduced. There follows a series of pitch oscillations as the control inputs are made. The effect of the inputs on the controllability decrease as the airspeed decreases.

It is possible that the steep descent angle of  $-14^\circ$  may have caused a weight shift forward of some of the remaining cargo, moving the CG forward. This in combination with the reduced throttle setting and reduction in the thrust moment, could cause the aircraft to pitch nose down if uncorrected.

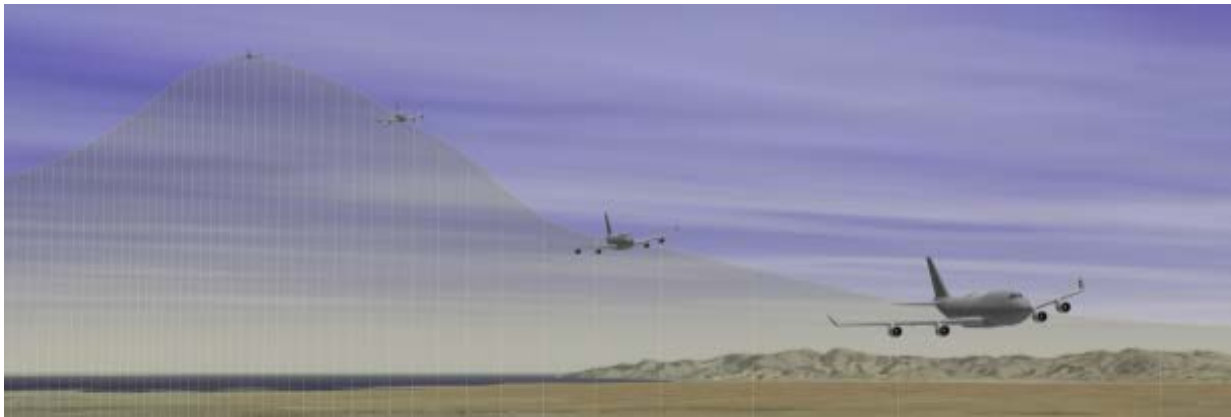
Figure 45 Profile: Descent and Pitch Oscillations

The PF made a series of inputs into the elevators which had a limited effect on the descent profile; the descent is arrested temporarily. There then followed a series of rapid pitch oscillations. These were not phugoid oscillations, but commanded responses where the elevator effectiveness decreased rapidly as the airspeed decayed and the elevators could not compensate for the reduced thrust moment from the engines to maintain level flight in a steady state. This was due to the de-synchronisation of the control column inputs and the elevators reduced trailing edge travel.

Had the aircraft remained on this heading and descent profile it would have intercepted the terrain at or near a large urban development, Silicone Oasis.

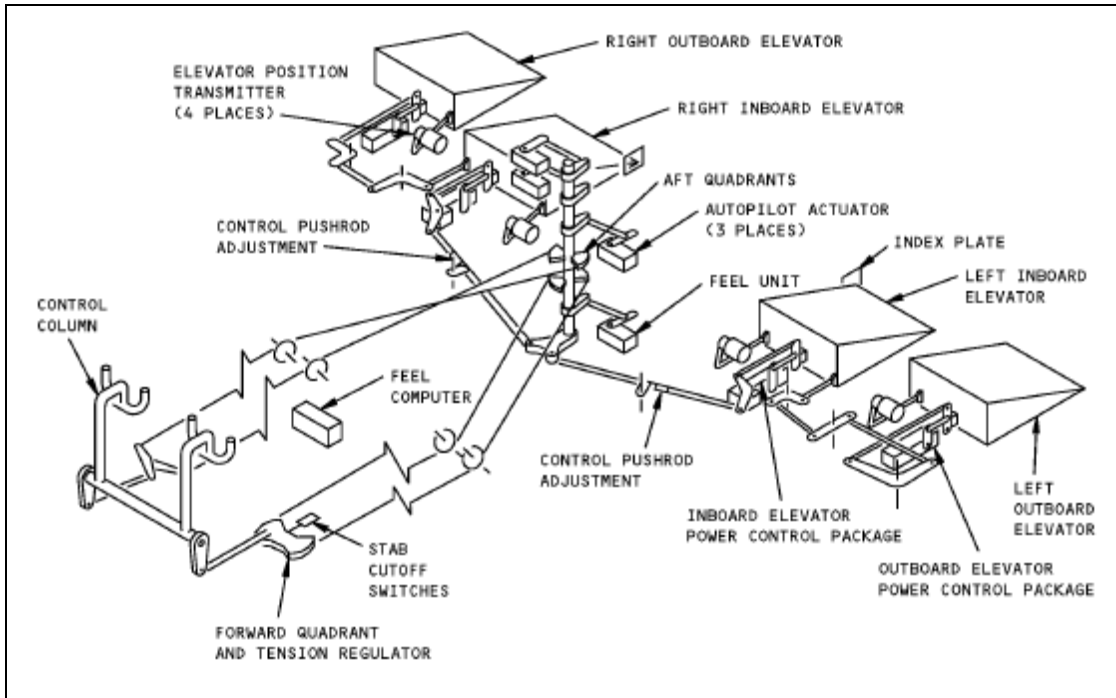
Figure 48 Elevator control system schematic from the Aircraft Maintenance Manual

All of these indications are consistent with a decrease in elevator control cable tension.

The elevator control system schematic is shown in Section 1. The cable that connects the forward and aft quadrants requires tension for the column movements to translate into elevator movements.

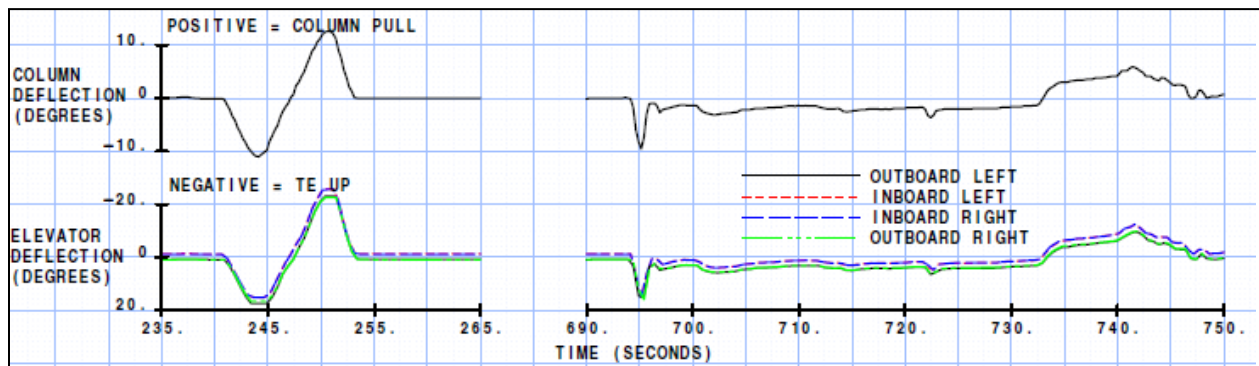
Figure 49 Column sweep and take-off rotation

Column sweep and take-off rotation display the normal relationship between column and elevator. If the tension is below the allowable tolerance, the column and elevator will no longer be consistent.

Following the initial fire warnings the column moved nose-down with no corresponding change in elevator deflection (left plot Fig. 49 above).

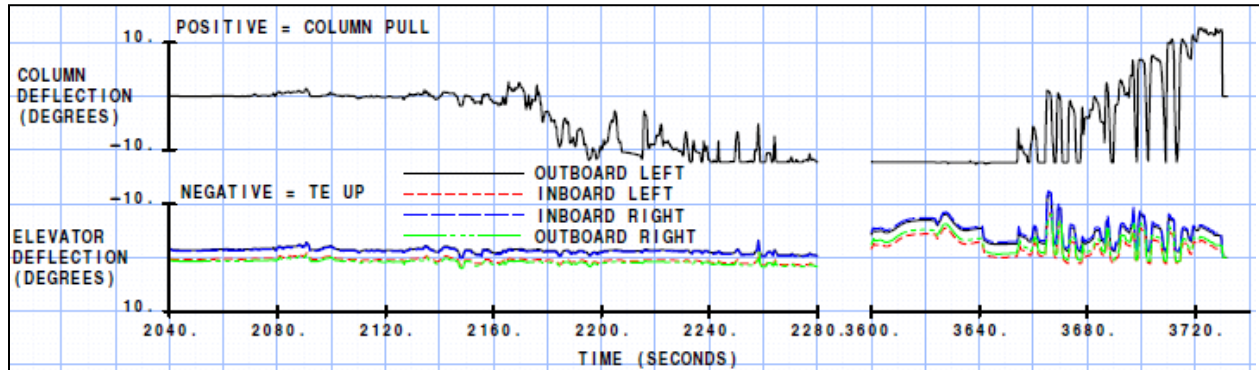
Figure 50 Column to Elevator deflections following the initial fire warnings and just prior to end of data.

Near the end of the data, the FDR data shows nose-up column inputs

The elevator was deflecting with the column inputs but not with the relative magnitude seen in the figure below. This indicates that there was some column cable tension but not enough to maintain normal column to elevator gearing.

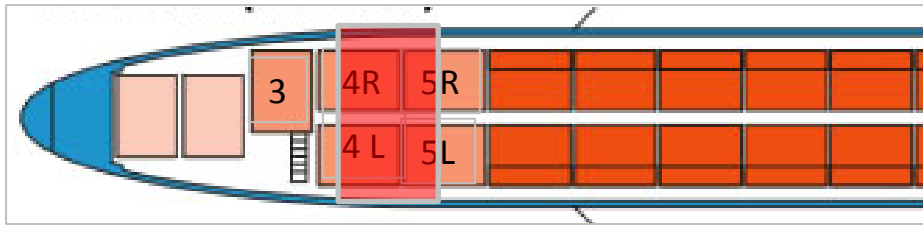
Zone 3 is approximately defined by the volume between STA 580 and STA 700, where the ceiling begins sloping up at the cargo liner transition point. This immediately below the LH and RH truss assemblies supporting the flight control cables

As shown in the diagram above, smoke zone 3 encompasses the area occupied by the forward portion of ULD no.'s 5L and 5R, as well as most of ULD no.'s 4L and 4R on the main deck.

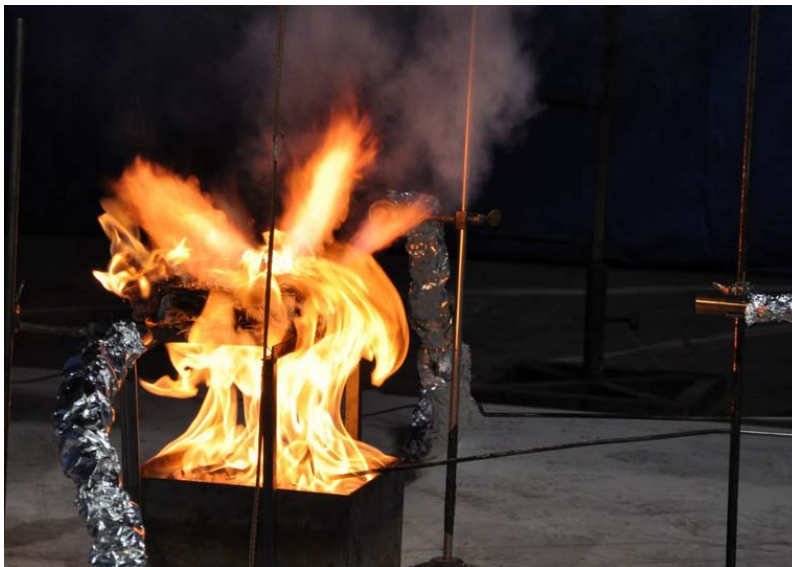
Photo 3- Venting of the electrolyte from a battery exposed to fire.

This can ignite the cargo providing sufficient thermal energy to ignite the adjacent cargo, which included, but did not entirely consist of, lithium batteries.

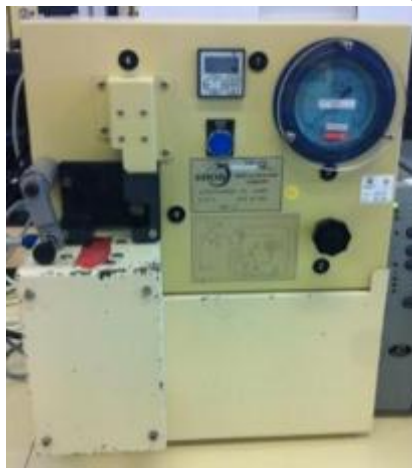
Figure 73 : Photo of 098869 test bench

There are no abnormalities on the graphs. Response time of the membrane is within the expected values. Additional tests were performed on test bench 098869 using on our production line.

Values were not recorded, however closing time was between specified values of 0.95 s and 1.30 s for both oxygen regulators.

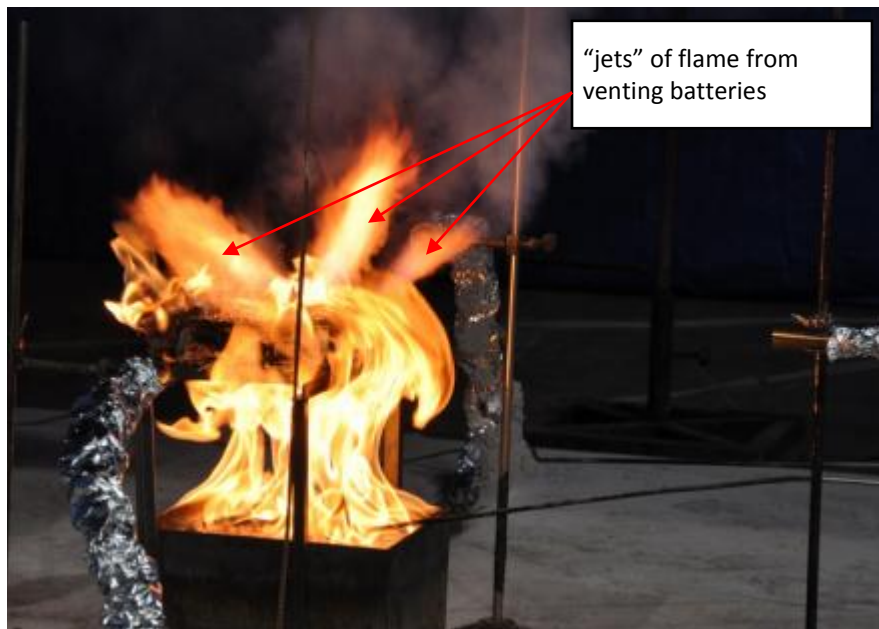
Figure 84: Box of lithium-ion batteries burning over propane burner exhibiting battery venting and electrolyte combustion

Due to the violent nature of the battery case venting and combustion of the electrolyte, some of the batteries (or battery components) were liberated from the charred packaging and propelled several feet, landing onto the floor. Some of these projectiles continued to burn upon landing.

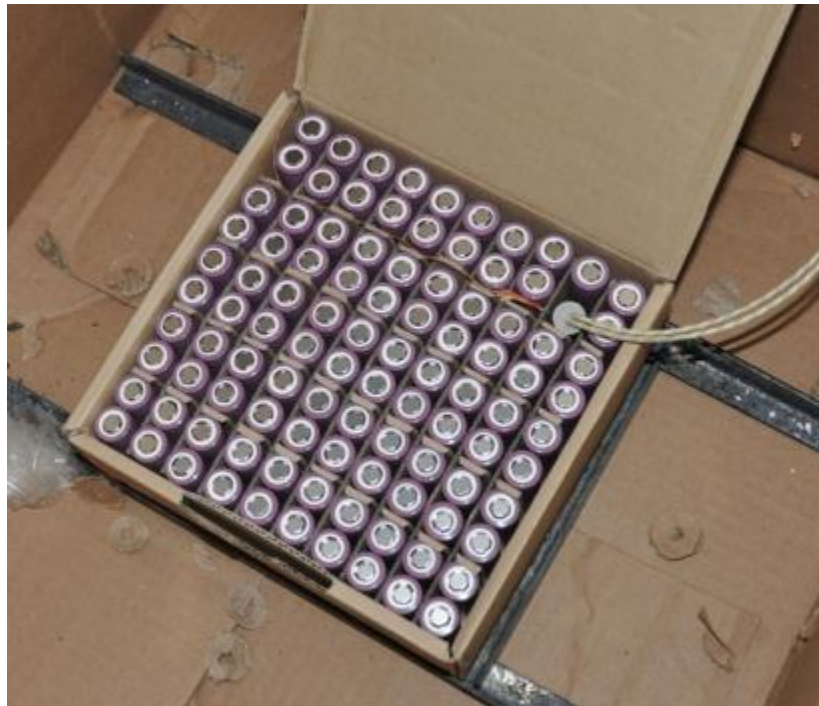
Figure 86: Box of batteries with cartridge heater in place (circled in red)

To simulate the case of batteries being the cause of the fire and self-igniting, a 250-watt cartridge heater was used to simulate a battery going into thermal runaway. One cell in the corner of the box of 100 batteries was replaced by the cartridge heater (figure 12). In addition to the batteries, the fire load for each of the two tests included 18 cardboard boxes each containing 2.5 lb of shredded paper inside, arranged in a 3 x 3 array two levels high (figure 13). Each cardboard box was an 18" cube. The box of batteries was placed inside the cardboard box (and covered with 2.5lb of shredded paper) at the center of the top level of boxes in the array. The additional fire load was used to observe the battery thermal runaway spread to the rest of the combustibles and to determine if the presence of batteries in the fire load had any measureable effect. For reference, two control tests were conducted using 18 boxes and no batteries. Those fires were initiated by an electric match inside the cardboard box at the center of the top level of boxes in the array, just as in the tests that included the box of batteries.

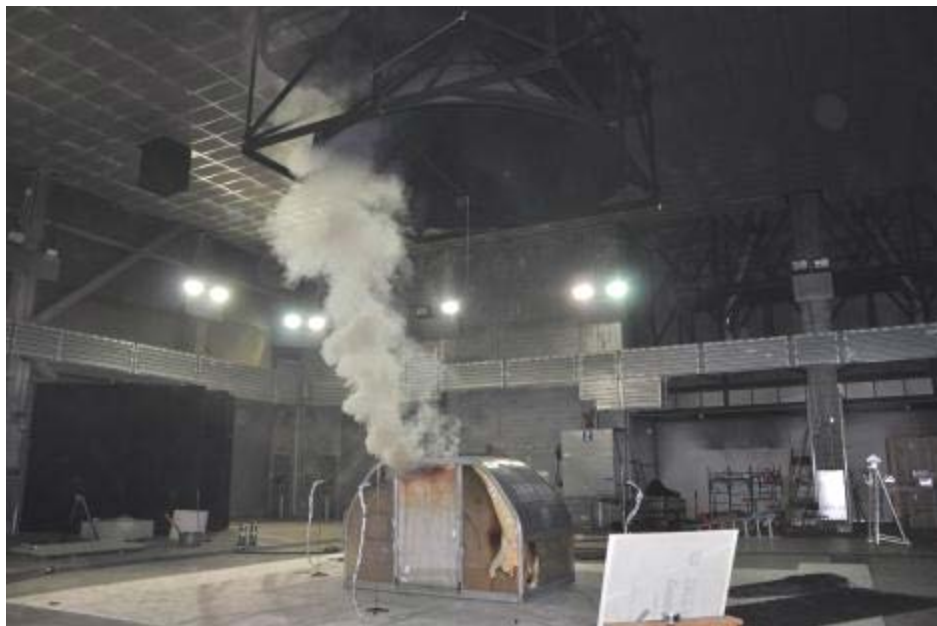
Figure 91: Smoke exiting above roll-up door on A2N type container

The results from both tests were in good agreement with each other. The peak energy release rates were 3.6 MW and 3.7 MW and the total energy released was 1530 MJ and 1690 MJ for tests 1 and 2, respectively. With regard to the smoke generation and its ability to exit the container, the observations made are noted on the graphs depicting the energy release rate of each test (figures 18 and 19). The first signs of smoke were observed to be exiting from the top portion of the roll-up door as expected. Two noteworthy time

intervals are of particular importance. The first is the time between a fire being established inside the container and smoke beginning to exit the container in sufficient quantity to trigger an alarm, 199 seconds and 150 seconds for tests 1 and 2, respectively. The second is the time interval between the fire becoming detectable and the time to reach peak energy release rate, 450 seconds and 630 seconds for tests 1 and 2, respectively.

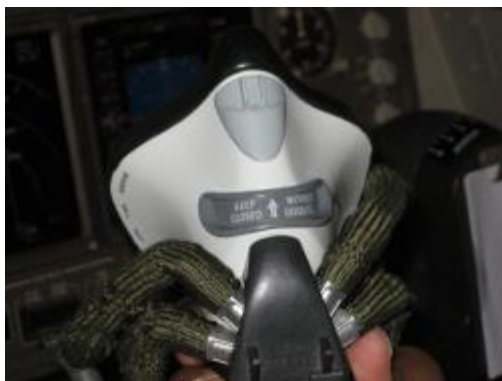
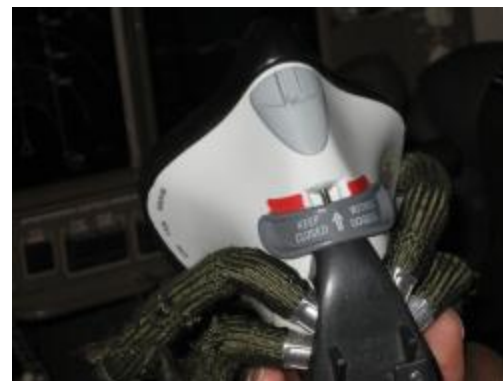
Figure 101: Smoke vent valve selector (closed)      Figure 102: Smoke vent valve selector (open)

The pilots involved in the exercise indicated that with the smoke goggles donned, it was difficult to find the switch to clear the goggles of smoke (see figures 9 and 10) and one stated “it was “awkward”.

The pilots did not believe they would have thought to clear the goggles if they had not practiced it before the scenario. Pilot #1 stated that it was a misconception that the goggles should fit snugly. He said they were designed to be loose so that the goggles could be cleared of smoke. The instructor informed the crew that they should have completed the smoke fire and fumes checklist prior to completing the smoke removal checklist. Asked who would be in charge of communicating with ATC, both pilots indicated that the PM would do this.

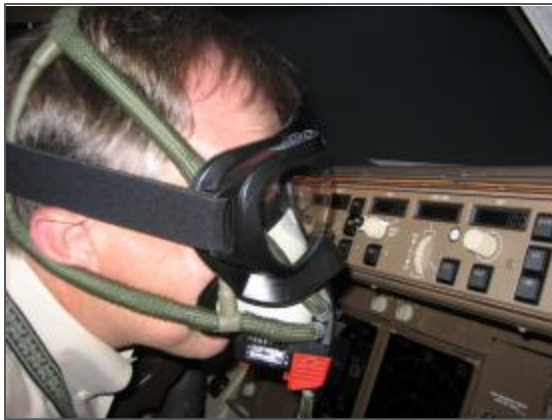
Figure 103: Closest position to the MCP

Pilot #2 indicated that with the smoke goggles donned, he could not see the standby compass. He said the image was distorted and he would have gotten his flashlight to improve visibility of the compass. Figures 11 and 12 show how close a pilot could get to the instrument panel with the oxygen mask and goggles donned.

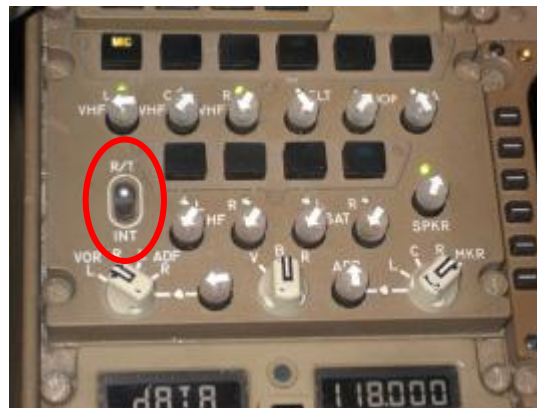
Figure 105: “Push to Talk” switch

Pilot #1 stated that not having a live mic could be an issue. He said if he did not hit the lower rocker (the “push to talk” switch on the audio panel; see figure 13), pilot #2 could not hear him. It was difficult to do this when holding the checklist.

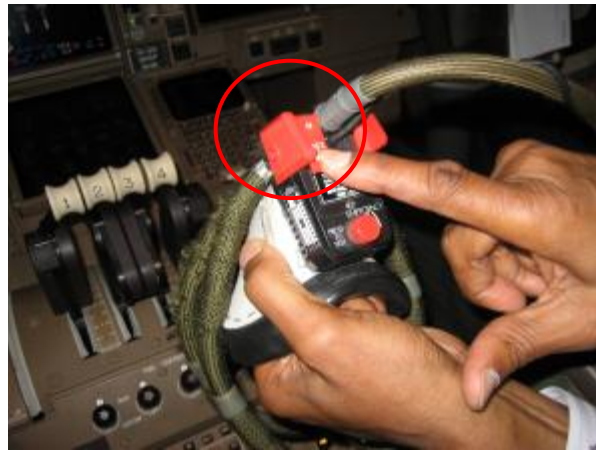
The pilots in the exercise did not know about preflight maintenance of O2. Regarding the different oxygen levels of the oxygen mask (see figure 10), “Normal” was a mix of ambient air and oxygen and the higher you get, the more O2 that was introduced, “100%” was 100% oxygen and “emergency” was positive pressure and 100% oxygen.

Figure 106: 100% Selector Switch on Oxygen Mask

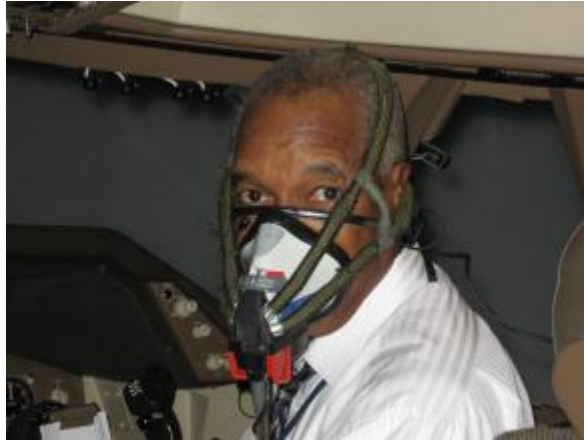
It took approximately 28 seconds for the crew to don both the oxygen mask and smoke goggles. It took an additional 6 seconds for the crew to establish crew communications. The scenario was run two times and both times the headset was knocked off when donning the oxygen mask (see figure 15).

Figure 107: Headset location after donning mask

Pilot #2 also indicated that to don the oxygen mask with the headset on, the pilot would have to move the boom of the headset to get the right seal on the mask. With the mask on, the crew could communicate using the rocker switch on the audio panel or on the control yoke.

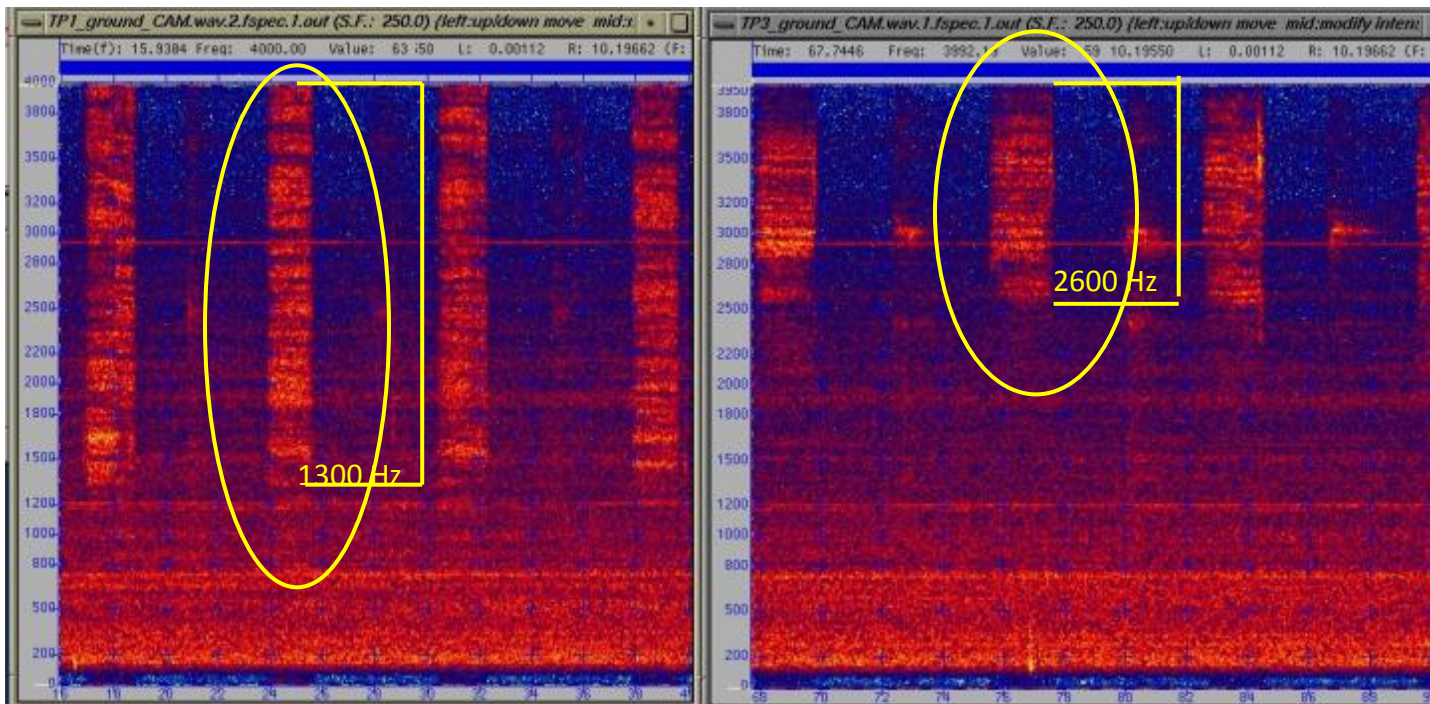
Figure 108 – Spectrogram of CAM - Test points 1 and 3, on Ground

The left side of Figure 107 shows the sounds during TP1 (mask in Normal mode). One of the inspiratory noises is circled in yellow. This chart shows a relatively equal distribution of sound energy over a range from about 1300 Hz to 4000 Hz. In contrast, the right side of Figure 107 shows the audio from TP3 (100%) mode, where the majority of energy is spread over a range from about 2600 Hz to 4000Hz. This is consistent with the auditory review of the recording which indicated that 100% mode sounded as though it had a higher pitch. This spectrogram shows that the 100% mode actually has less sound energy in the lower frequency range, which causes it to sound as though it has higher pitch when compared to the Normal Mode.

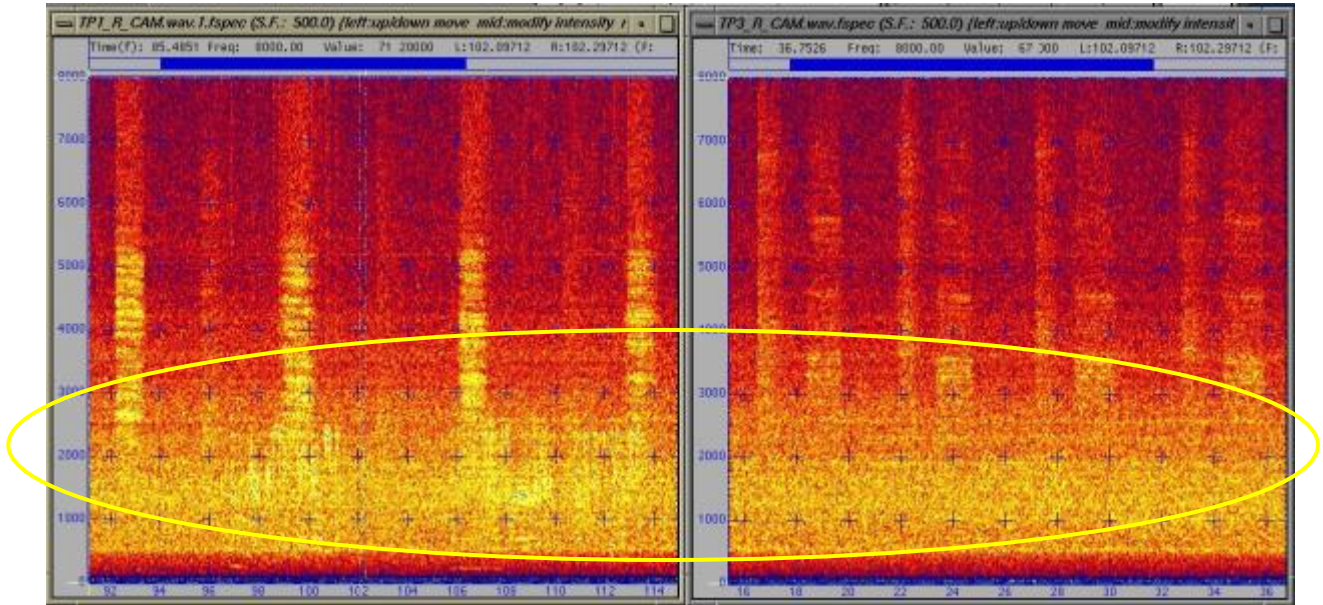
In flight, this characteristic is much more difficult to discern, due to the background ambient noise in the cockpit. The area highlighted in Figure 108 shows the background noise during flight is too loud to see the lower frequency range of the inspiratory noise. As a result, this characteristic was not suitable to differentiate between mask modes.

Figure 109 - Spectrogram of CAM - Test points 1 and 3, During Flight

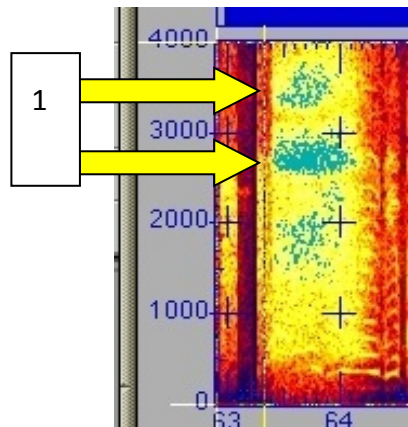
The auditory review of the mask microphone audio revealed that the breath noises did not sound significantly different between the two mask modes. However, the sound spectrum analysis found a unique characteristic in the audio that differentiates one mask mode from the other. Figure 109 shows a spectrogram of the inspiratory noise from a single breath, as recorded from the oxygen mask microphone.

Figure 110 – Spectrogram of Inspiratory Noise from Mask Microphone Audio

The audio from the mask microphones exhibits characteristic “bands” of energy during inspiratory breaths (light blue regions labeled 1 and 2 in Figure 109). These bands are a concentration of relatively higher sound energy within certain frequency ranges. The height of the bands (range of frequency) and total number of bands seems to vary, and may be affected by the overall loudness of the breath sound itself. However, two of these bands are present in all segments of audio that were examined (labeled 1 and 2 in Figure 109). The unique characteristic is the “center” frequency of Band 2. The band height (total frequency range) can vary, but the center of the band appears to be unique to the mask mode. In
