# **AIR ACCIDENT INVESTIGATION SECTOR**

# **AIR ACCIDENT INVESTIGATION REPORT**

Uncontained Cargo Fire Leading to Loss of Control  
Inflight and Uncontrolled Descent Into Terrain

Boeing 747-44AF  
N571UP  
Dubai  
United Arab Emirates  
03 September 2010

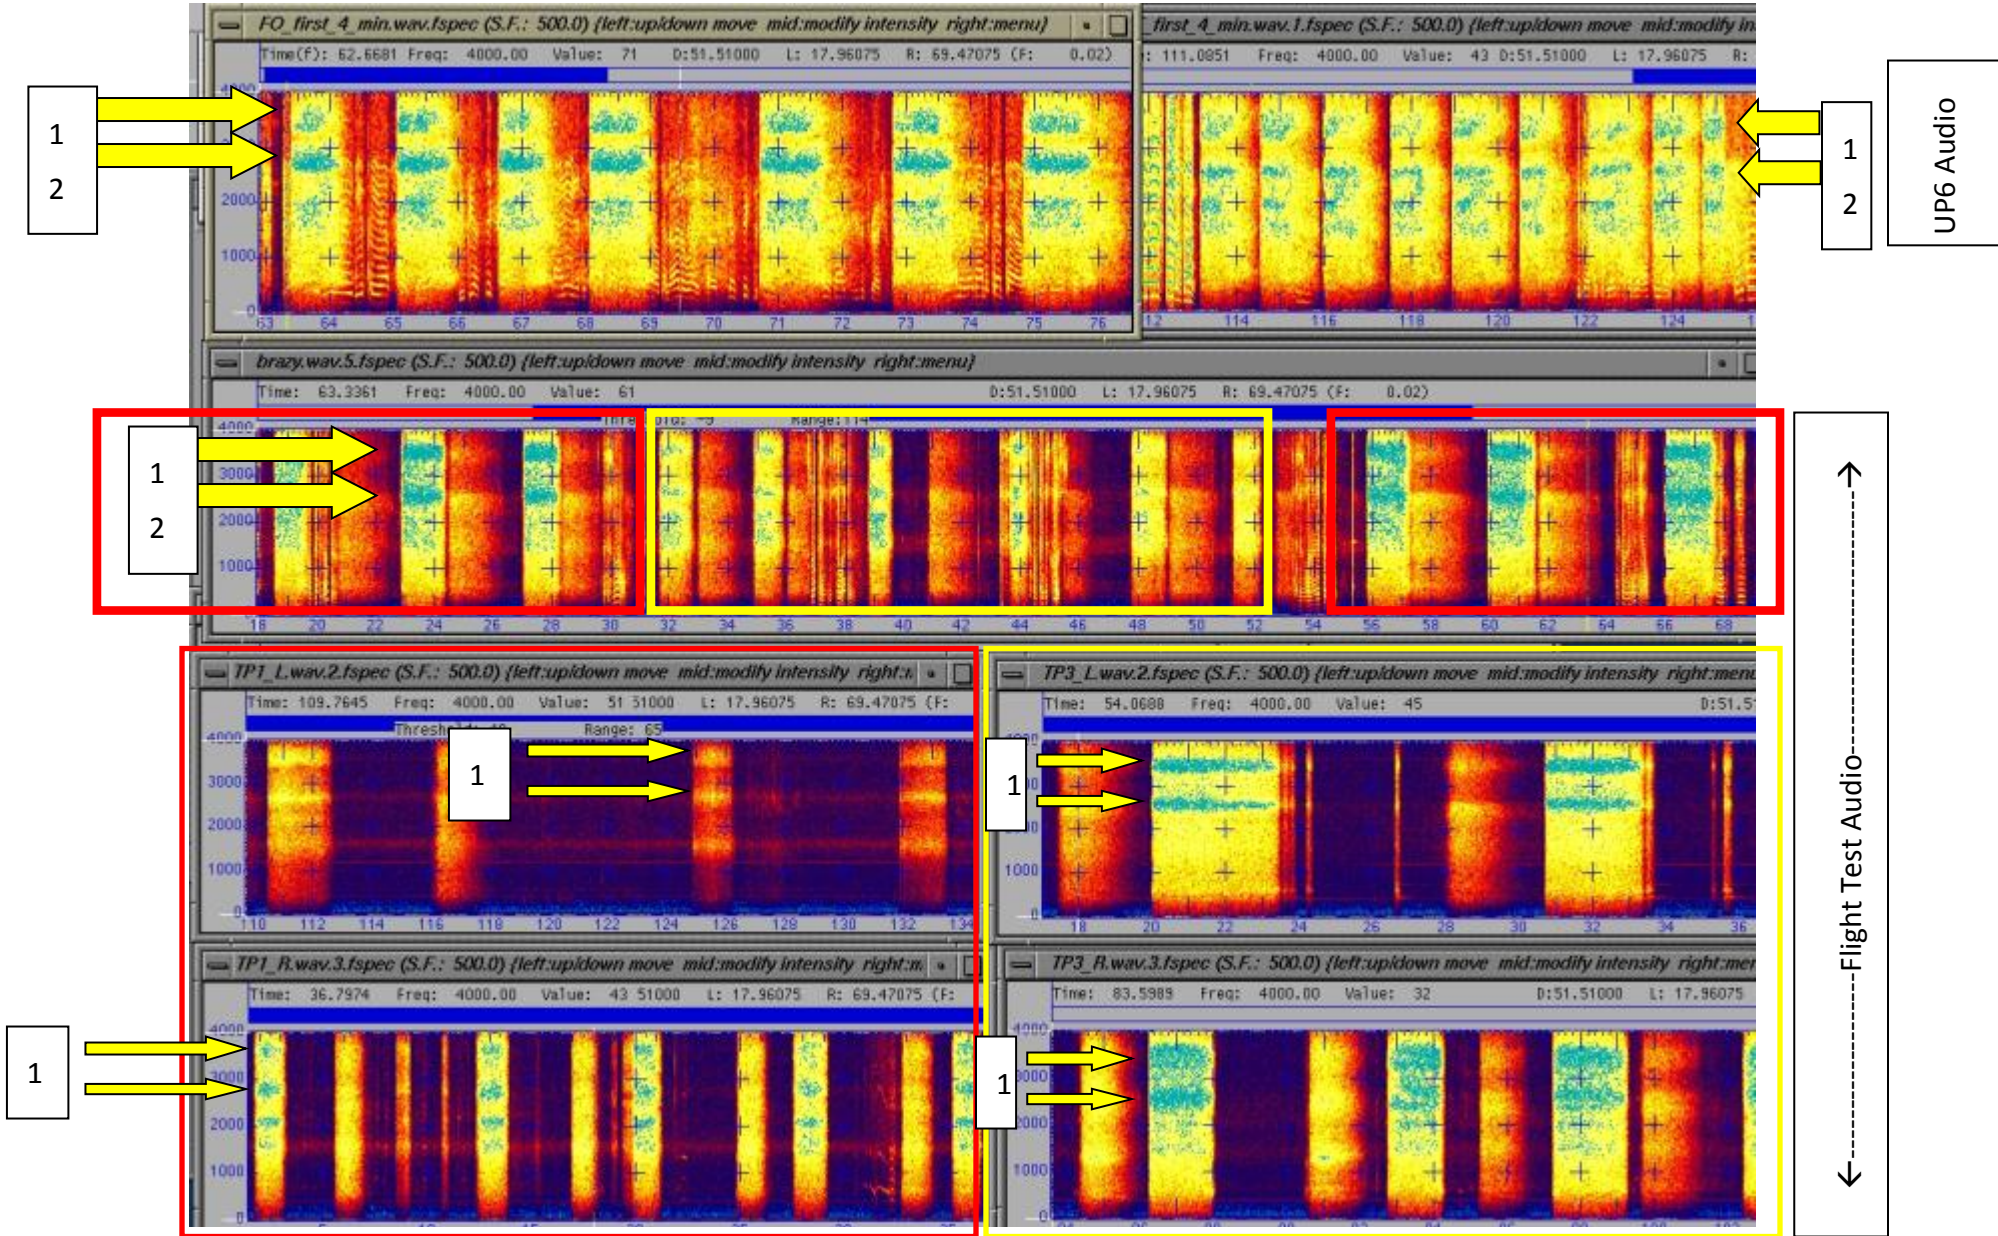
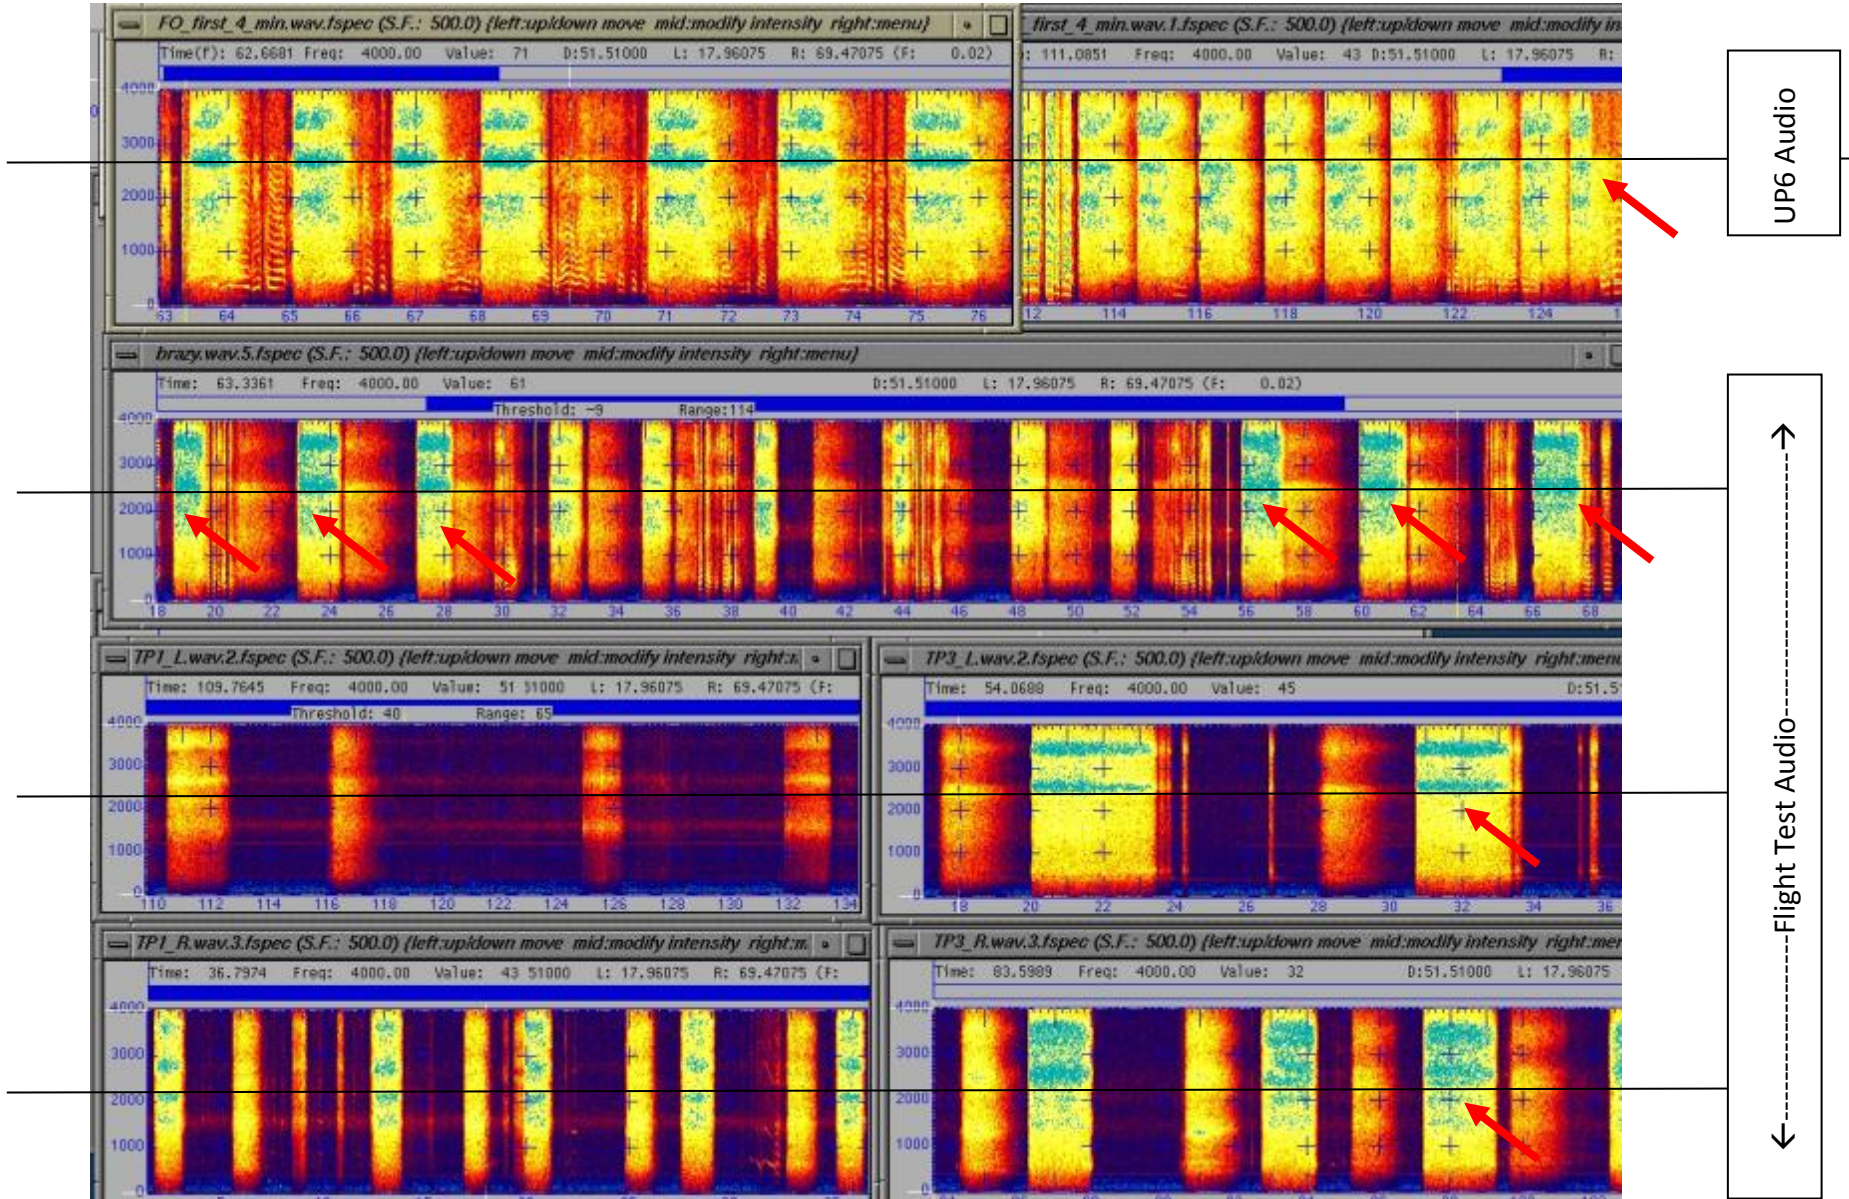
The audio from the accident airplane is at the top of **Error! Reference source not found.**. The left hand side shows the audio from the First Officer's mask microphone, with the center of band 2 at approximately 2700 Hz which is consistent with the Normal mode. The right side shows the audio from the Captain's mask microphone, with the center of band 2 at about 2560 Hz, consistent with the 100% mode.

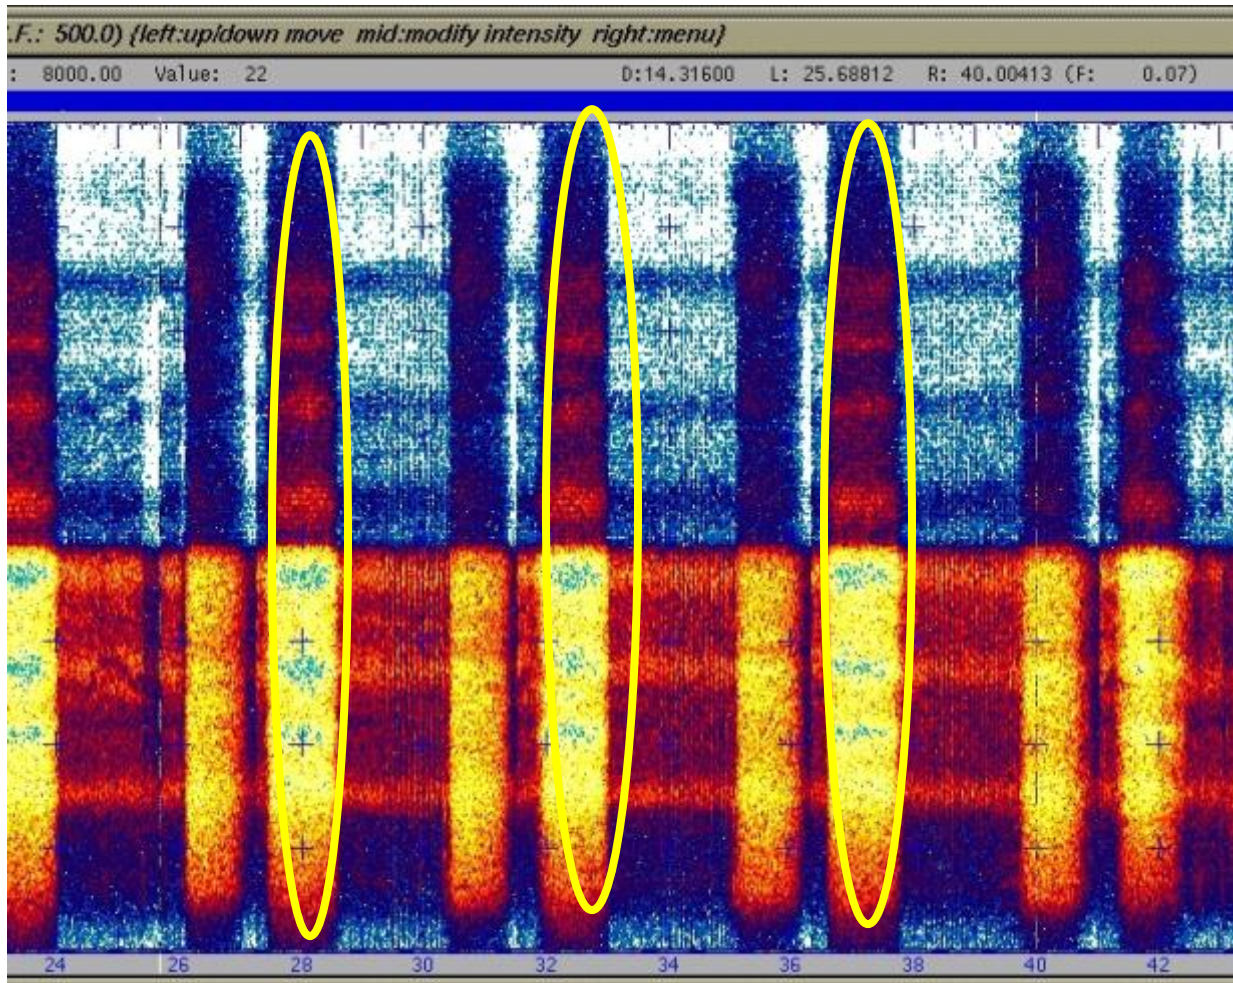
During the testing in the NTSB laboratory as well as the flight test, a characteristic was noted which appears to be consistent with the emergency setting set to “on”. This characteristic can be heard audibly as well as seen in a spectrogram. It is a “chattering sound” that occurs between breaths. This characteristic is not continuous and only occurs occasionally, however it occurred at some point during every test when the emergency setting was on, and did not occur in any tests when the setting was off. None of the audio on the accident recording contained this characteristic. The “chattering” is visible as the series of thin dark vertical lines highlighted in Figure 110.

Figure 111 - Emergency Setting = On
